Township of Muskoka Lakes

Port Carling Arena Rehabilitation Project

ADDENDUM # 2

Visual Review of the Port Carling Arena

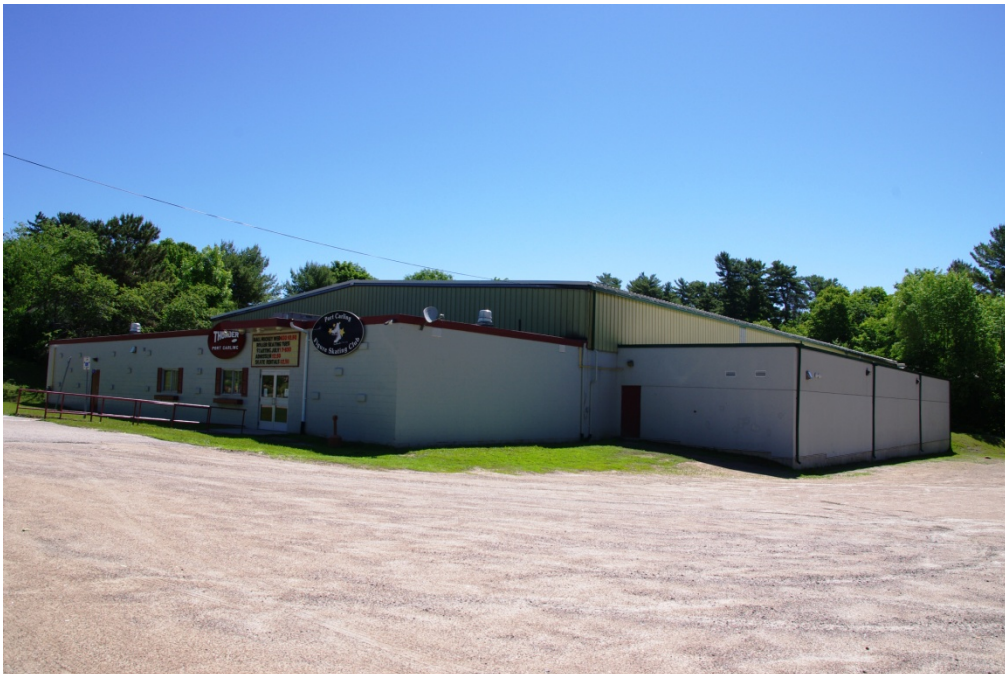
Photo 1 - West (Front) Elevation (South – West Corner)

The exterior surface of the west wall has been painted and generally appears to be in good condition. However, there are some minor void mortar joints that require re-pointing.

The grading on the west side / front of the building is not sloping away from the building. It is recommended to add a north – south swale in front of the building to allow the grading to be sloped towards the swale, away from the building.

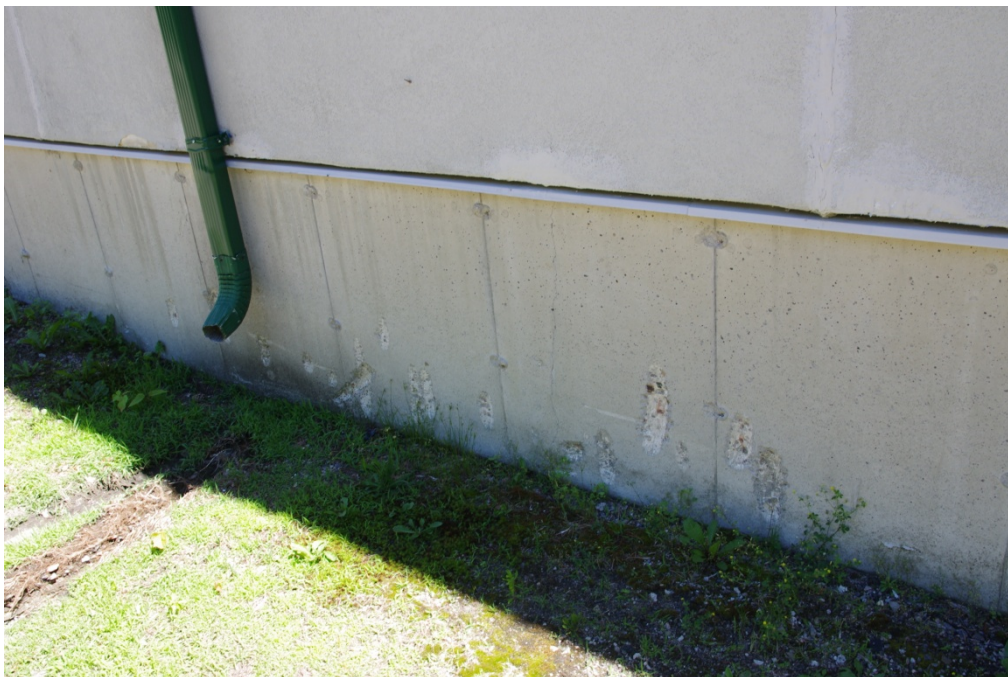
The south side addition above grade wall has an exterior stucco finish that is supported on a poured concrete foundation wall. The foundation wall contains some minor vertical shrinkage cracks and minor spalls. The stucco appears to have been vandalized, as it contains several small impact dents, many of which appear to have been patched. Also, there are several vertical full height cracks that have been sealed and are in need of re-caulking. Some of these full height cracks may have been control joints or related to shrinkage.

Photo 3 – South Side – Shrinkage Crack & Spalls / Damage

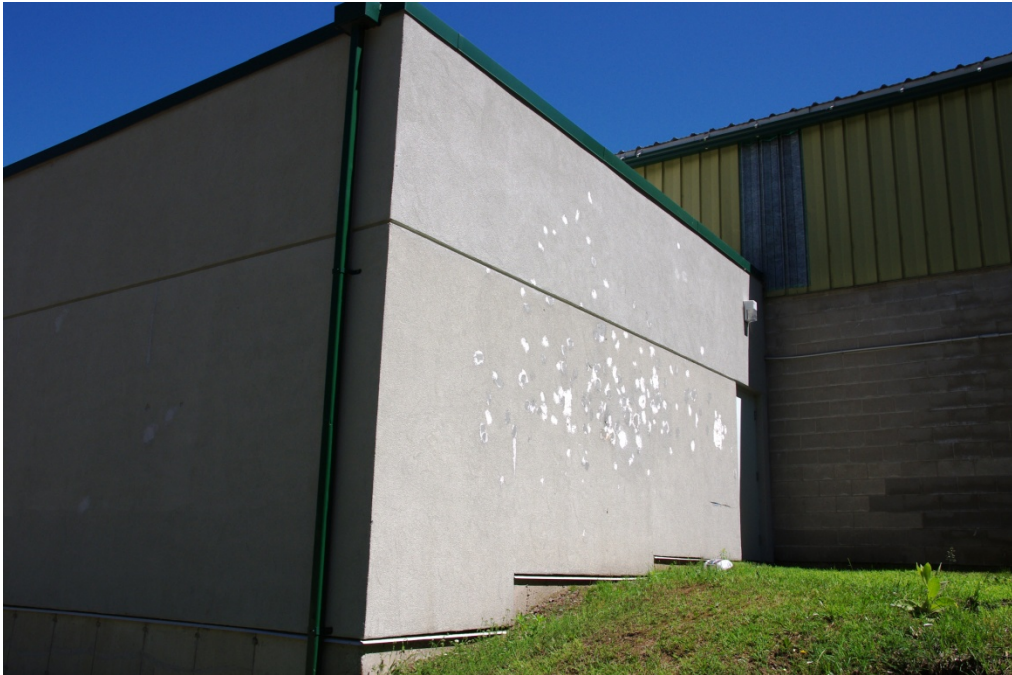
Photo 4 – North End of South Side Addition – Vandalism to Stucco Finish

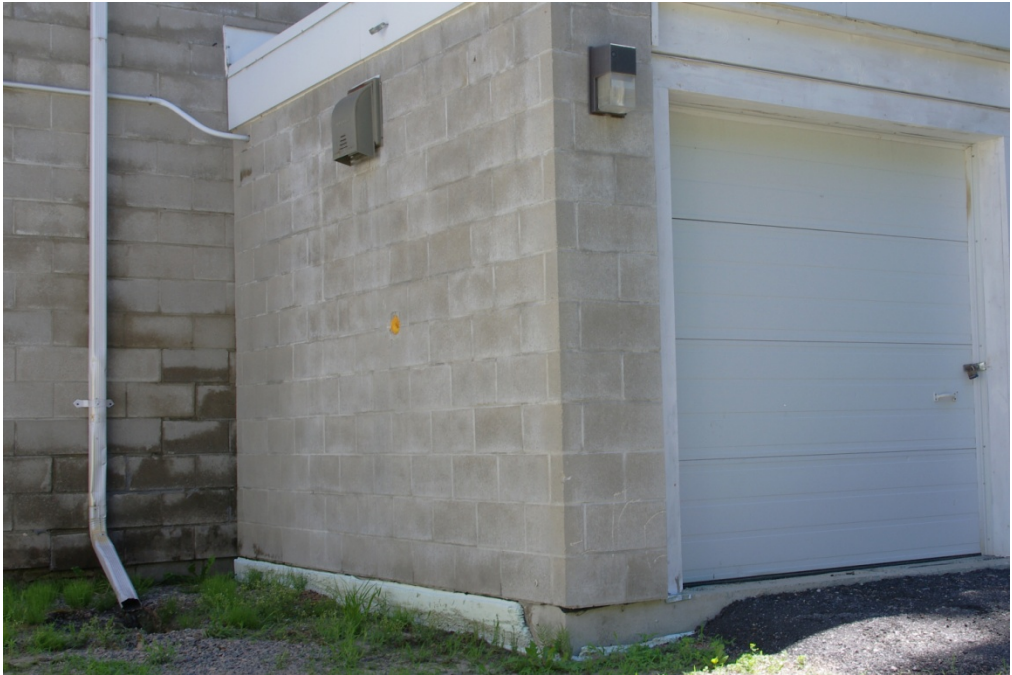
The foundation walls at the base of the Zamboni room have been insulated on the exterior face with 2" of rigid insulation that extends above grade by approximately 8" on the west side and approximately 1" or 2" on the south and east side. This insulation is not intended to be exposed to UV solar rays, and if left exposed it will break down over time. It is recommended that this insulation be cut off approximately 8" below grade or covered with an appropriate cladding to protect it against UV deterioration. As well, on the east face of the Zamboni room there is a section of rigid insulation exposed near the top of the wall where it appears that an opening in the wall has been filled in with insulation. This surface should be parged or filled in with block to match the adjacent wall.

Photo 5 – Zambonie Room – Exposed Rigid Insulation

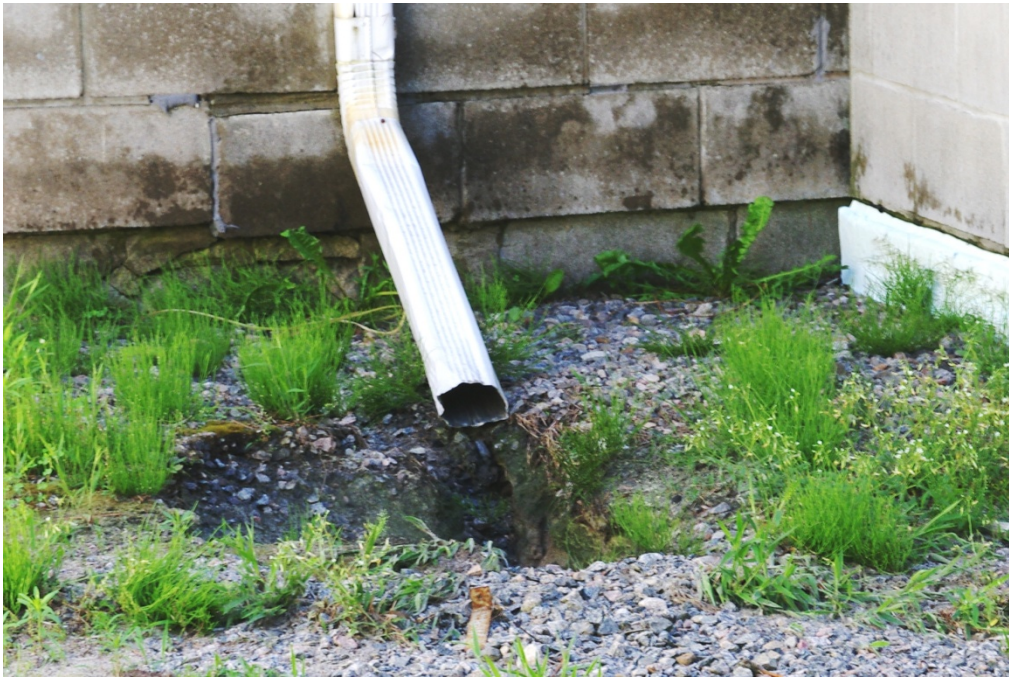
There are some damaged blocks at the base of the eavestrough downspout adjacent to the Zamboni room, as well as a significant pot hole from erosion at the outlet of the downspout. All cracked or damaged block should be replaced and any cracked, loose or void mortar joints should be raked out and re-pointed.

Photo 6 – Damaged Block & Erosion Adjacent to Zamboni Room

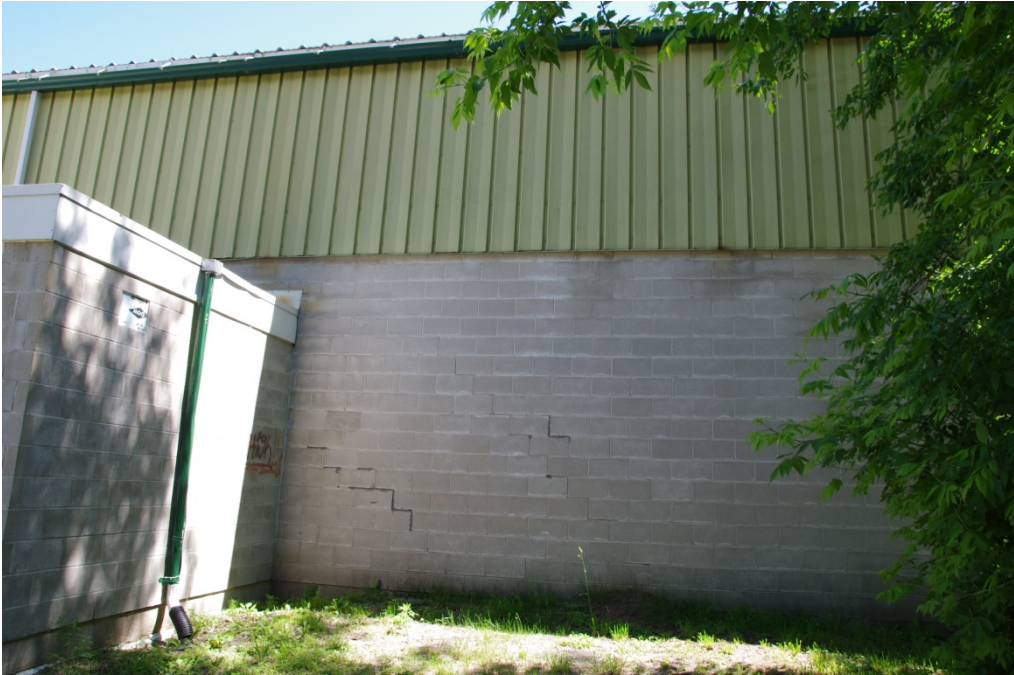
The south block wall just east of the Zamboni room contains some minor stepped cracking, some of which has previously been patched and is not re-cracked. All of the open cracks should be routed out and re-pointed.

Photo 7 – Stepped Cracking just East of Zamboni Room – South Wall

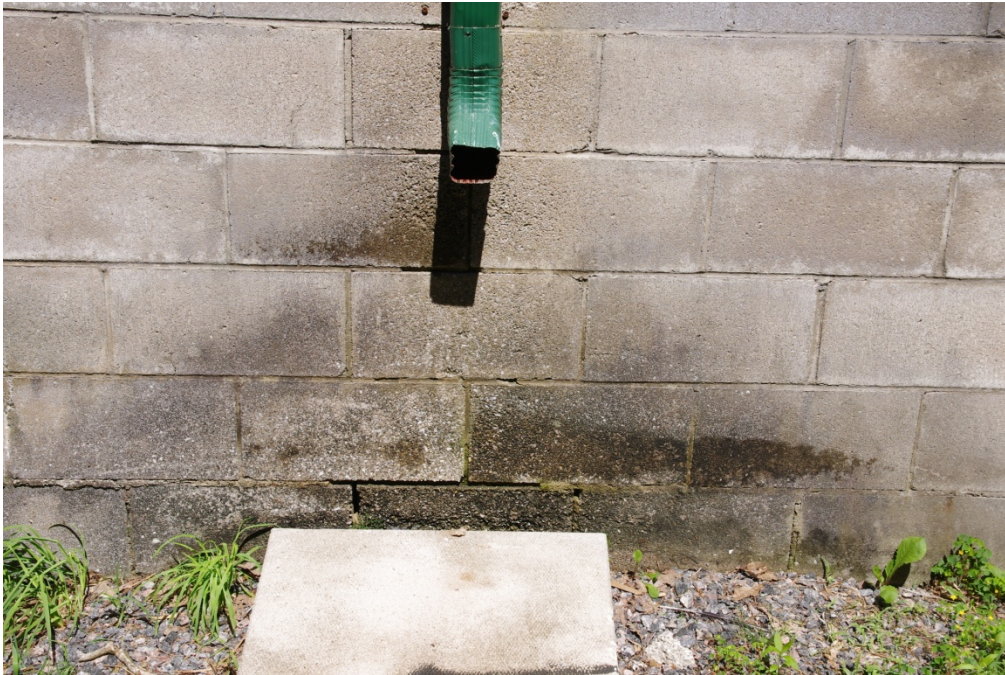
At the north east corner, the block wall is eroded around and below the downspout. As well, there is vegetation growing on the base of the wall adjacent to the downspout. The eroded block can be sealed with an appropriate paint or spray on sealer to prevent further water infiltration and erosion.

Photo 8 – East Wall – Eroded Block at Downspout

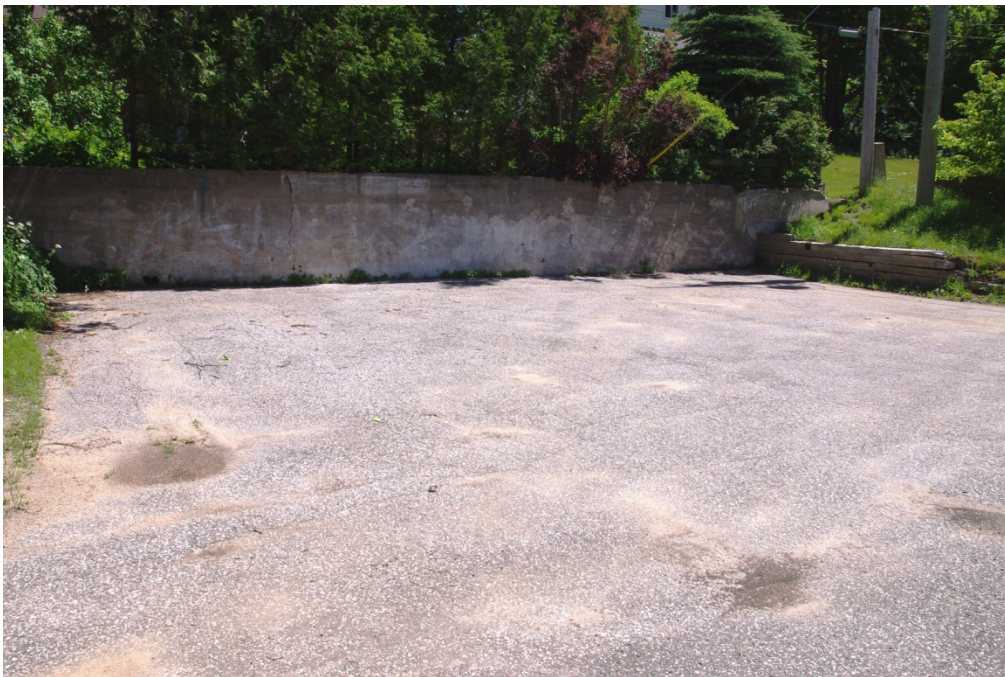
On the north side at the east end of the building there is a small paved parking area with an old concrete retaining wall on the north end and a timber retaining wall on the east end. Both retaining walls are retaining higher soil from the adjacent properties. These retaining walls are both in poor condition. The concrete wall contains some

significant vertical cracking that may or may not be repairable. Please note that we did not sound (i.e. hammer test) this wall for delaminations during our review. As a result we are unsure how extensive the damage / deterioration is. The reinforcing steel in close proximity to any significant cracks is likely severely corroded. As the reinforcing steel corrodes it expands, which results in concrete delaminations around the corroded steel. It may be possible to chip out any delaminated concrete and repair the wall, or alternatively the wall could be replaced. The timber retaining wall appears to contain significant rot and is likely at the end of its service life. The timber wall should be scheduled for replacement in the near future and the concrete wall should either be repaired or replaced.

Photo 9 – North Side – Deteriorated Retaining Walls

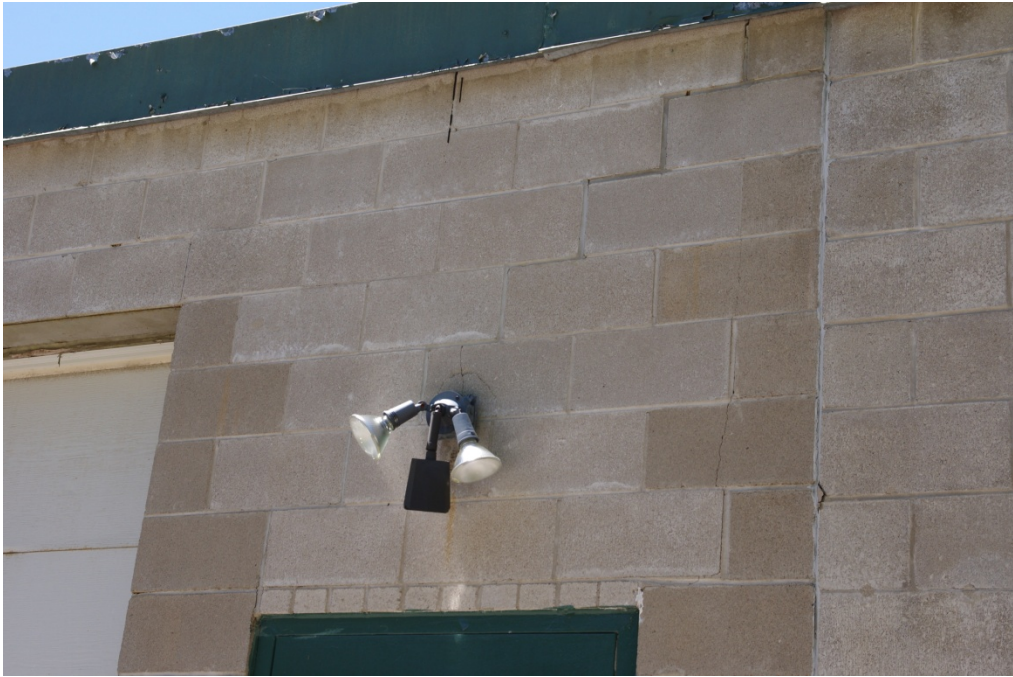
The block wall contains some minor stepped cracking as well as some cracks around the doors. Some block erosion is present at the downspouts. As previously noted, eroded blocks can be sealed with an appropriate exterior grade sealer, and all cracked or damaged block should be replaced and loose, void or cracked mortar joints should be raked out and re-pointed.

Photo 10 – North Side – Stepped Cracking

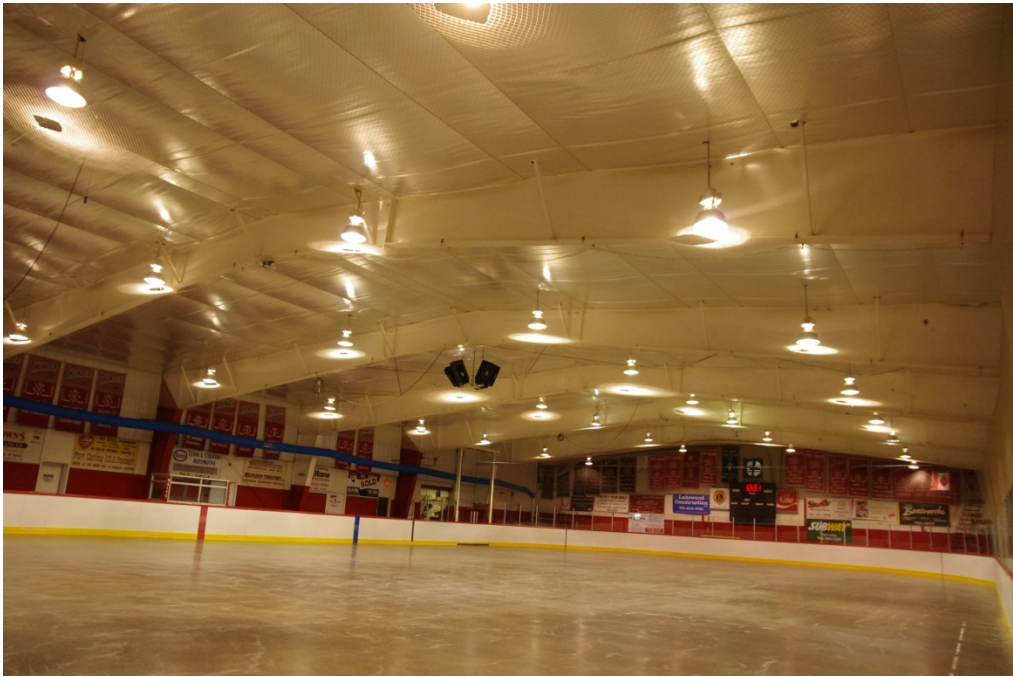
No signs of deterioration or distress were noted in the roof framing within the open arena area. The Low E insulated ceiling and netting recently installed obscures all of the existing high roof purlins and the upper portions of the rigid frames from view. We are unable to comment on the current condition of these purlins, as they were not exposed to view.

Photo 11 – Interior of Arena with Low E Ceiling below Roof Purlins

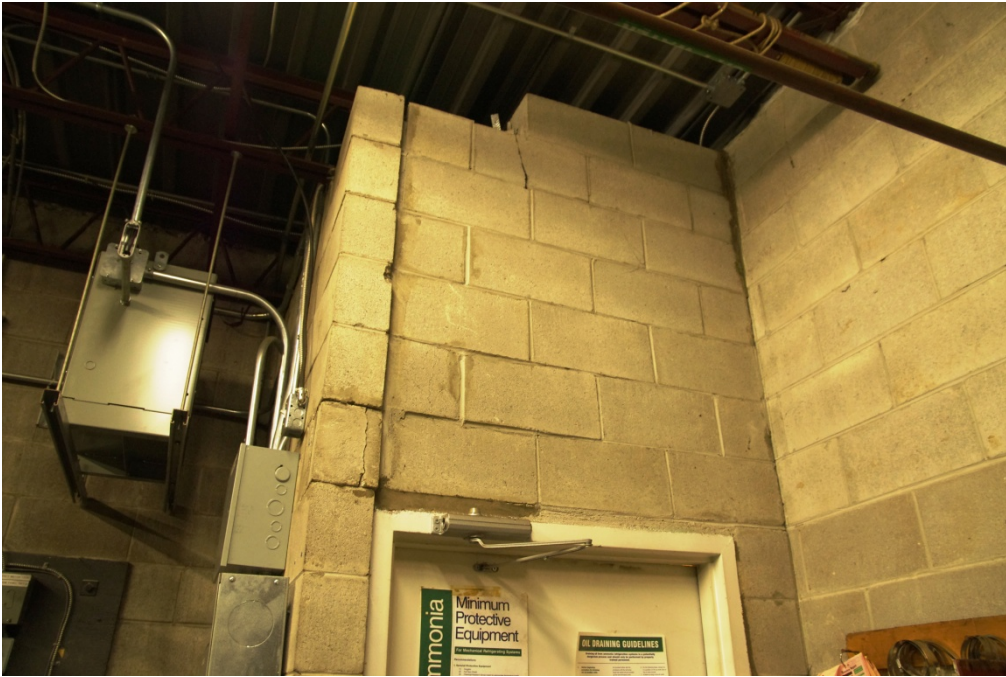
Adjacent to the man door, there was a damaged / cracked block present that should be removed and replaced.

Photo 12 – Plant Room – Damaged Block Adjacent to Man Door

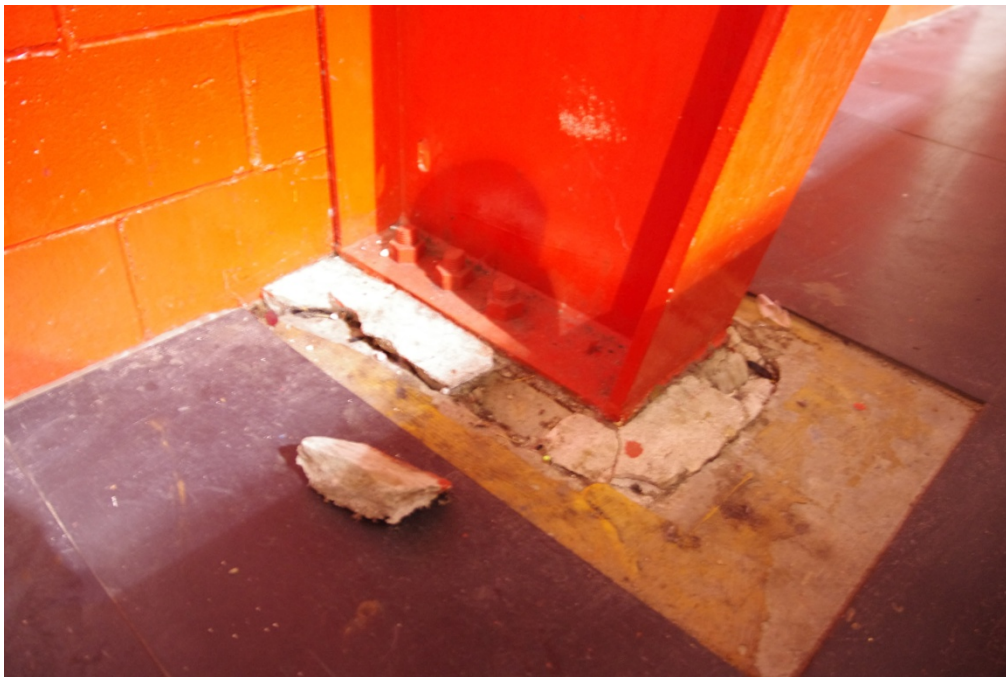
At the base of several of the rigid frame columns, the base plates are starting to rust and the grout below and around the base plates is severely cracked and crumbling. We recommend that all cracked and loose grout be removed

Photo 13 – Rigid Frame Base Plate with Cracked Grout on Pier

and replaced with new dry packed non-shrink grout. As well, all surface rust on the base plates should be removed and the base plates should be painted to slow any future corrosion.
