MEMORANDUM

Date: Thursday, November 17, 2022

RE: Burgess Dam - North Slope Geotechnical Investigation and Slope Stability Analysis

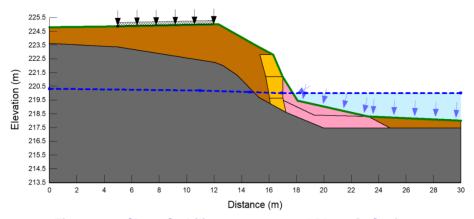
Figure 6-1: Slope Stability Geometry and Phreatic Surface

The slope stability model resulted in a global factor of safety of 1.24, the required factor of safety for the current site conditions is typically 1.5. A sensitivity study where the gabion basket netting has deteriorated was also run, this yielded a factor of safety of 0.61 showing that without a gabion wall in good condition, the slope is unsafe and would likely fail. The condition of the gabion wall below the rockfill at the downstream toe is unknown as it is covered in rock fill, however given its age and the fair condition of the existing gabion wall it is reasonable to assume that the gabions are nearing the end of their service life and it is recommended that they be rehabilitated or replaced.

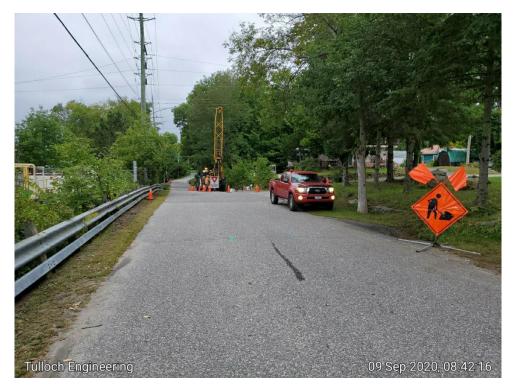
Photo 1: General investigation area, note low powerlines on left side of photo which prevented drilling closer to the North Slope. Powerhouse on left.

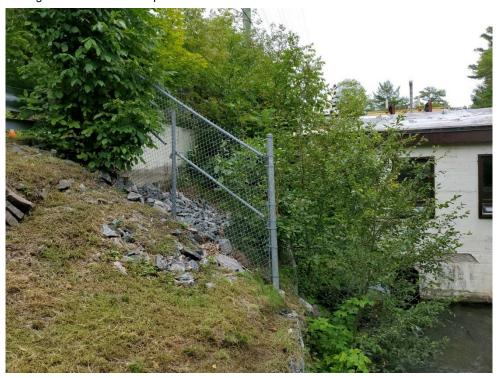
Based on the results, the existing concrete retaining wall is typically in a safe condition. However, when the U/S water level is high, i.e., at the surface of the fill, the factor of safety decreases to a marginally safe condition with the required Safety Factor for overturning not being met. This condition likely occurs during period of high precipitation, during the spring freshet and is also likely during an overtopping event. Buildup of water pressure on the upstream side of the wall is expected due to the lack of drains through the retaining wall. It is also noted that a large, open vertical crack exists in the retaining wall which indicates historic movement. Continued deterioration and movement of the wall may cause further reduction in overall stability if left unchecked.

The existing concrete retaining wall is noted to have extended vertical cracks from the crest to the soil contact on the downstream side. Further, typical features of modern retaining walls including subdrain system, and reinforcement in the form of anchor points or dowelling were not apparent on historical drawings or observed during the last DSR conducted in 2019. This indicates that the wall is in fair condition and should be rehabilitated or replaced. Given the planned rehabilitation of the overall facility replacement or remediation of this wall is recommended at this time.

Photo 2: Retaining wall near road surface, gabion basket wall at slope toe. Powerhouse on right. Image looking from downstream of powerhouse to upstream.

- Cracks in the concrete retaining wall should be repaired and if required additional structural reinforcement should be added.
- Anchoring of the concrete retaining wall into the shallow bedrock should be considered to improve stability in overturning and sliding.

- The concrete retaining wall and repair locations should be regularly inspected for further movement over time. A monitoring system could be implemented on the wall to track movement in the future.

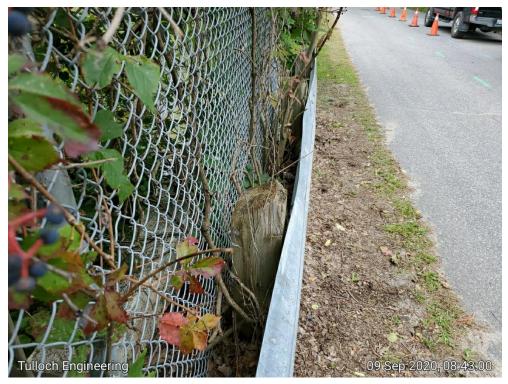
Photo 3: View of retaining wall behind the fence from road surface.

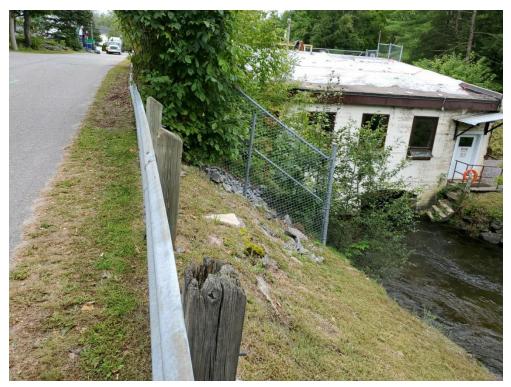
The gabion wall is noted to be in marginally unsafe condition, with some unknowns as to the geometry and foundation. The North Slope is noted to be steep at approximately a 1.75 to 1 (H:V).

Photo 4: North Slope with powerhouse and tailrace in background on right. Note abrupt slope change where gabion basket wall exists at break in slope.

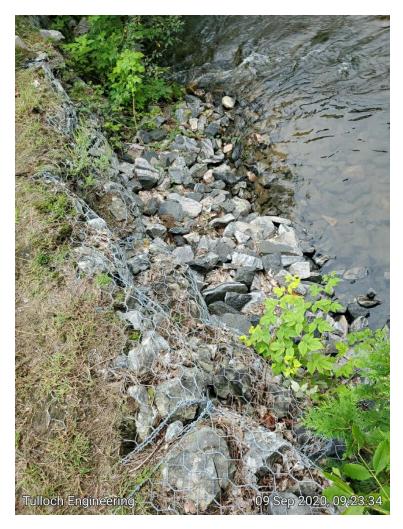
Based on the above results, the stability of the gabion basket retaining wall is in a marginally unsafe condition. The internal stability of the wall does not meet the required safety factor with respect to sliding. The rockfill at the toe of the wall has been ignored in this analysis due to its discontinuous nature, however, in reality it may provide minor support to the lower two gabions. Continued deterioration and movement of the wall will likely cause further instability if left unchecked. Therefore, action is recommended to remediate or replace the Gabion Wall which will be discussed in Section 7.

Photo 5: Gabion wall at toe of North Slope. Note rockfill located at toe of gabion wall above tailrace water level.

- Removal of rockfill at the toe of the gabion wall to inspect the lower Gabions and determine
 their condition, the Gabions could then be remediated or replaced as required. Adequately
 sized rip rap and/or larger gabion stone could be used to prevent erosion and help stabilize
 the North Slope.
