MUNICIPAL CLASS ENVIRONMENTAL ASSESSMENT BURGESS 1 DAM

20-1051

Little Burgess Dam Rehabilitation Existing Conditions and Environmental Impact Assessment

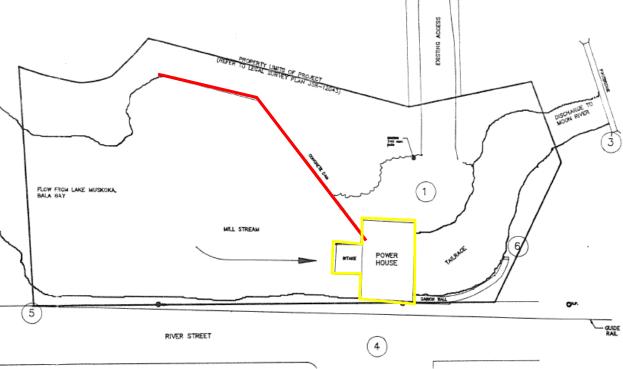
- Flooding event of spring 2019 caused overtopping of the dam
- Emergency actions were taken and flooding event was mitigated
- This event triggered a Dam Safety Review for the Burgess Dam Facility

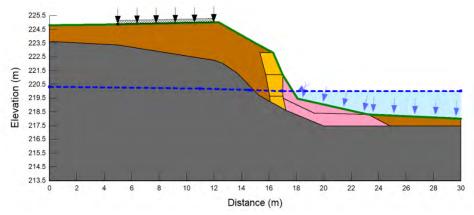
Figure 6-1: Slope Stability Geometry and Phreatic Surface

The slope stability model resulted in a global factor of safety of 1.24, the required factor of safety for the current site conditions is typically 1.5. A sensitivity study where the gabion basket netting has deteriorated was also run, this yielded a factor of safety of 0.61 showing that without a gabion wall in good condition, the slope is unsafe and would likely fail. The condition of the gabion wall below the rockfill at the downstream toe is unknown as it is covered in rock fill, however given its age and the fair condition of the existing gabion wall it is reasonable to assume that the gabions are nearing the end of their service life and it is recommended that they be rehabilitated or replaced.

The following recommendations should be implemented for rehabilitation of the North Slope area:

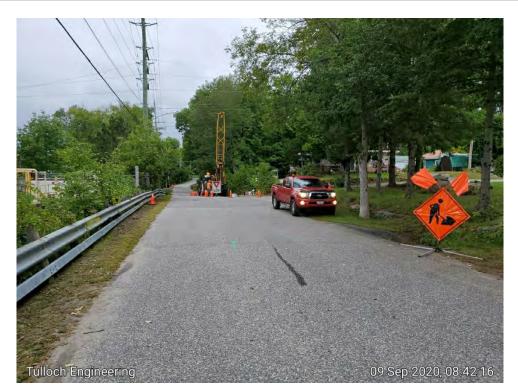
Photo 1: General investigation area, note low powerlines on left side of photo which prevented drilling closer to the North Slope. Powerhouse on left.

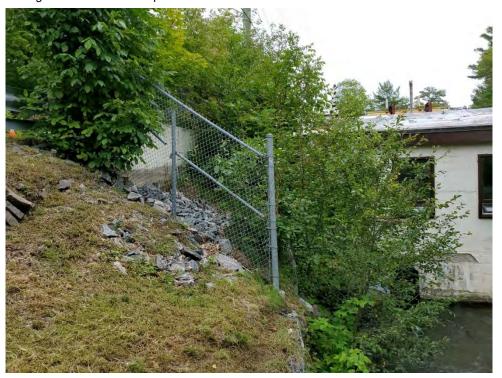
Photo 2: Retaining wall near road surface, gabion basket wall at slope toe. Powerhouse on right. Image looking from downstream of powerhouse to upstream.

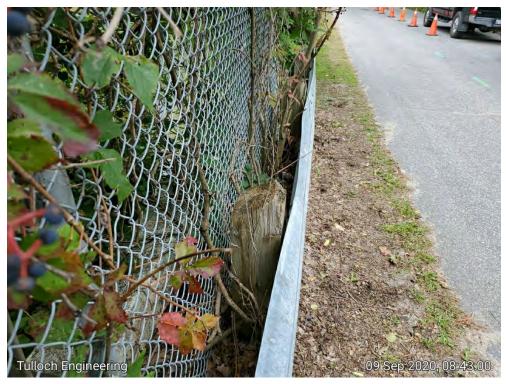
Photo 3: View of retaining wall behind the fence from road surface.

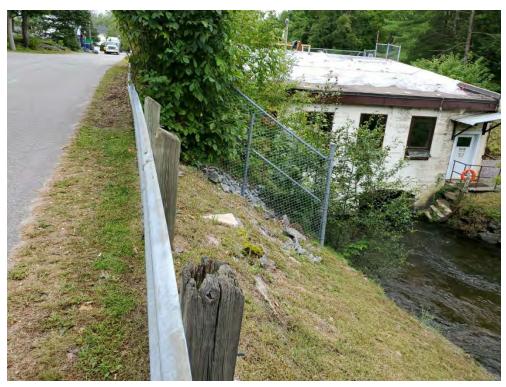
Photo 4: North Slope with powerhouse and tailrace in background on right. Note abrupt slope change where gabion basket wall exists at break in slope.

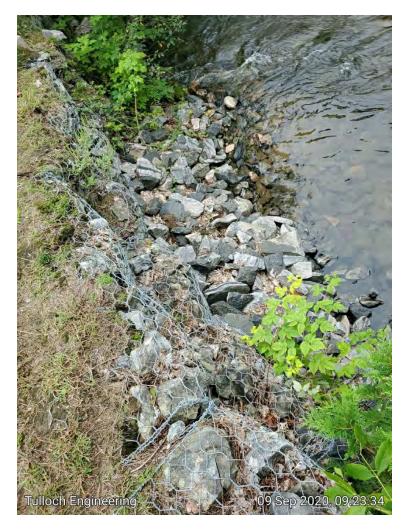
Photo 5: Gabion wall at toe of North Slope. Note rockfill located at toe of gabion wall above tailrace water level.
