DAM SAFETY REVIEW BURGESS 1 DAM

Township of Muskoka Lakes

September 6, 2019

TULLOCH Project No.: 19-1493

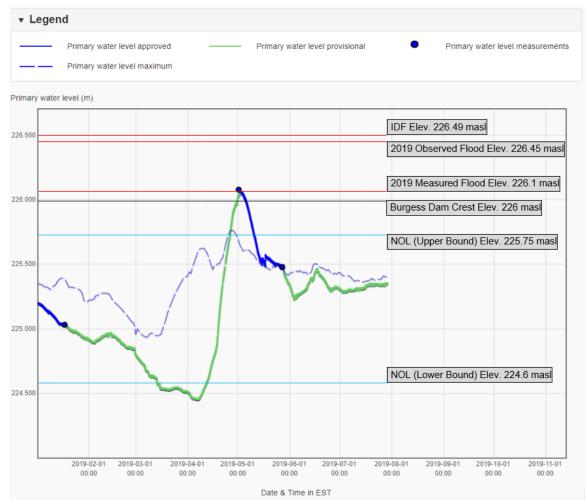
Figure 7-1: Burgess Dam 1 - 2019 Water Levels vs. NOL and IDF

- The maximum measured water level in 2019 during the flood event was at El. 226.1m at Gauge Station 02EB015, which occurred on May 1st, 2019;
- The IDF value provided by the MNRF and illustrated in the Muskoka River Dam Operation Manual for both the Bala Falls Dams is 226.49 masl and corresponds to the 100-year flooding event. The observed maximum water level at Burgess 1 Dam during overtopping in 2019 spring was at approximate El. 226.45m, which is very close the IDF (1/100yrs return) level of El. 226.49m;

- The existing Burgess 1 Dam crest is at El. 226 m. During the determined IDF event water levels are above the dam crest by 0.39 m. Therefore, it can be determined that the Burgess dam does not have sufficient freeboard nor was the existing facility designed to handle IDF in its current state.

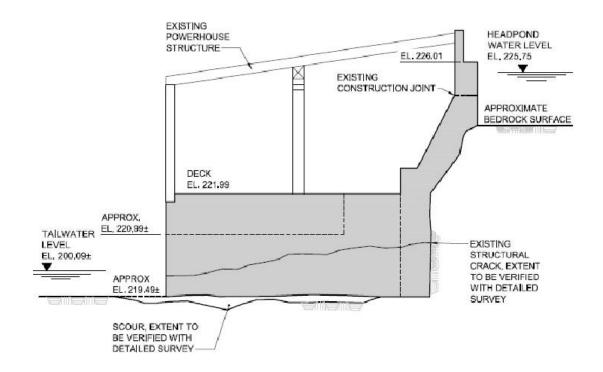
Figure 8-2: Typical Powerhouse Dam Section for Stability Analysis

- Under static loading condition with NOL at El. 225.75 m, the calculated FOS against sliding is 1.2, which does not meet the required minimum FOS of 1.5; The calculated FOS against overturning is 1.0, which does not meet the required minimum FOS of 2.0.
- Under seismic loading condition with NOL at El. 225.75 m, the calculated FOS against sliding is 1.2, which meet the required minimum FOS of 1.1; the calculated FOS against overturning is 1.0, which does not meet the required minimum FOS of 1.1. Due to a short dam height and low PGA value at the site, the seismic loading has a negligible impact on the stability of Burgess dam.
- Under static loading condition incorporating the IDF water level, the calculated FOS
 against sliding is 1.1, which meets the required minimum FOS of 1.3; The calculated FOS
 against overturning is 1.0, which does not meet the required minimum FOS of 1.3.

Based on the geotechnical stability assessment, Repair or mitigation measures must be developed for both the non-overflow dam section and powerhouse dam section to improve the FOS to meet the minimum acceptable criteria.
