CLIENT:	DRAWN BY:	CHECKED BY:	DES	IGNED BY:
TOWNSHIP OF	K. KORTEKAAS	E. GILES	G.	LIANG
MUSKOKA LAKES	APPROVED BY:	SCALE:	DATE:	
PROJECT:	G. LIANG	AS NOTED	2019-08-07	
BURGESS DAM 1		7.0		
	DRAWING No.			REVISION No.
DAM SAFETY ASSESSMENT	19-1493-C-01			Α

Stage 1 Archaeological Assessment of Burgess Dam Safety Assessment, Part Lot 14, Concession A, Township of Medora, Township of Muskoka Lakes, District of Muskoka

The Township has identified a need to complete an Environmental Impact Assessment to determine the best option for the Burgess Dam repair and or/ replacement. To assess the existing conditions and potential impacts of the proposed alternative solutions (Appendix A), Tulloch has performed a Natural Heritage Desktop Review of the site and surrounding area as well as an on-site field assessment. The Natural Heritage Desktop Review included areas within 1000 m of the proposed solution footprint. The Study Area for on-site assessments was defined as areas within 120 m of the proposed solution footprints. The information collected was used to identify impacts and appropriate mitigation measures for the proposed design alternatives.

Burgess Dam Rehabilitation/Replacement **Env

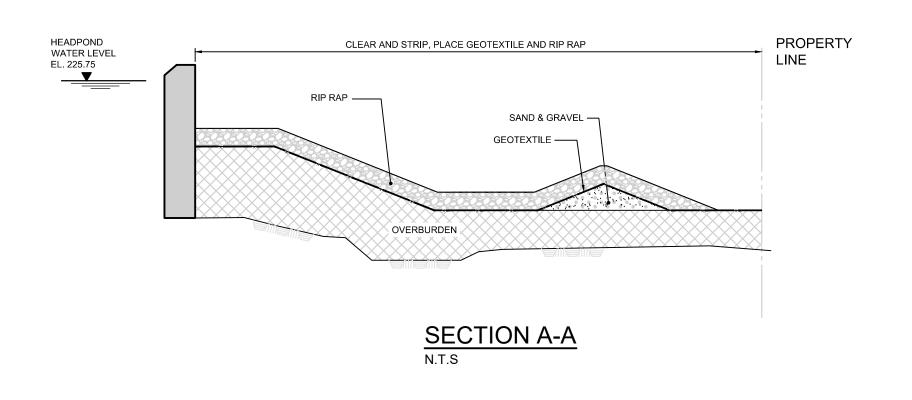
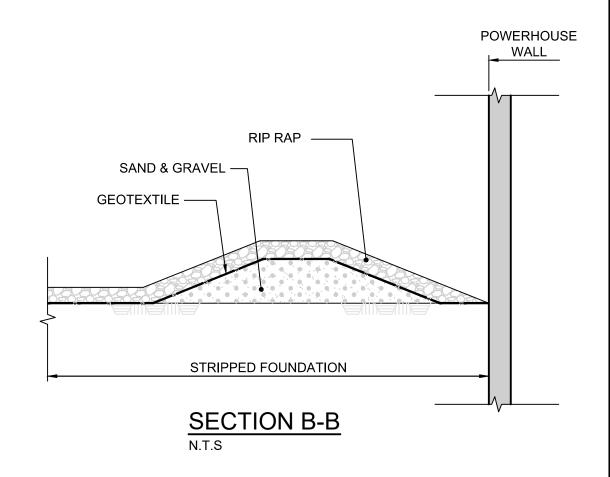
CLIENT:	DRAWN BY:	CHECKED BY:	DESIGNED BY:
TOWNSHIP OF	K. KORTEKAAS	E. GILES	G. LIANG
MUIO/(O)/A I AI/EO			
MUSKOKA LAKES	APPROVED BY:	SCALE:	DATE:
PROJECT:	G. LIANG	AS NOTED	2019-08-07
BURGESS DAM 1			
DURGESS DAWLI	DRAWING No.		REVISION No.
DAM SAFETY ASSESSMENT	19-1493-C-02		A

NON-OVERFLOW DAM SECTION
OPTION N1
UPGRADED DOWNSTREAM FILL
WITH TOE BERM - SECTIONS

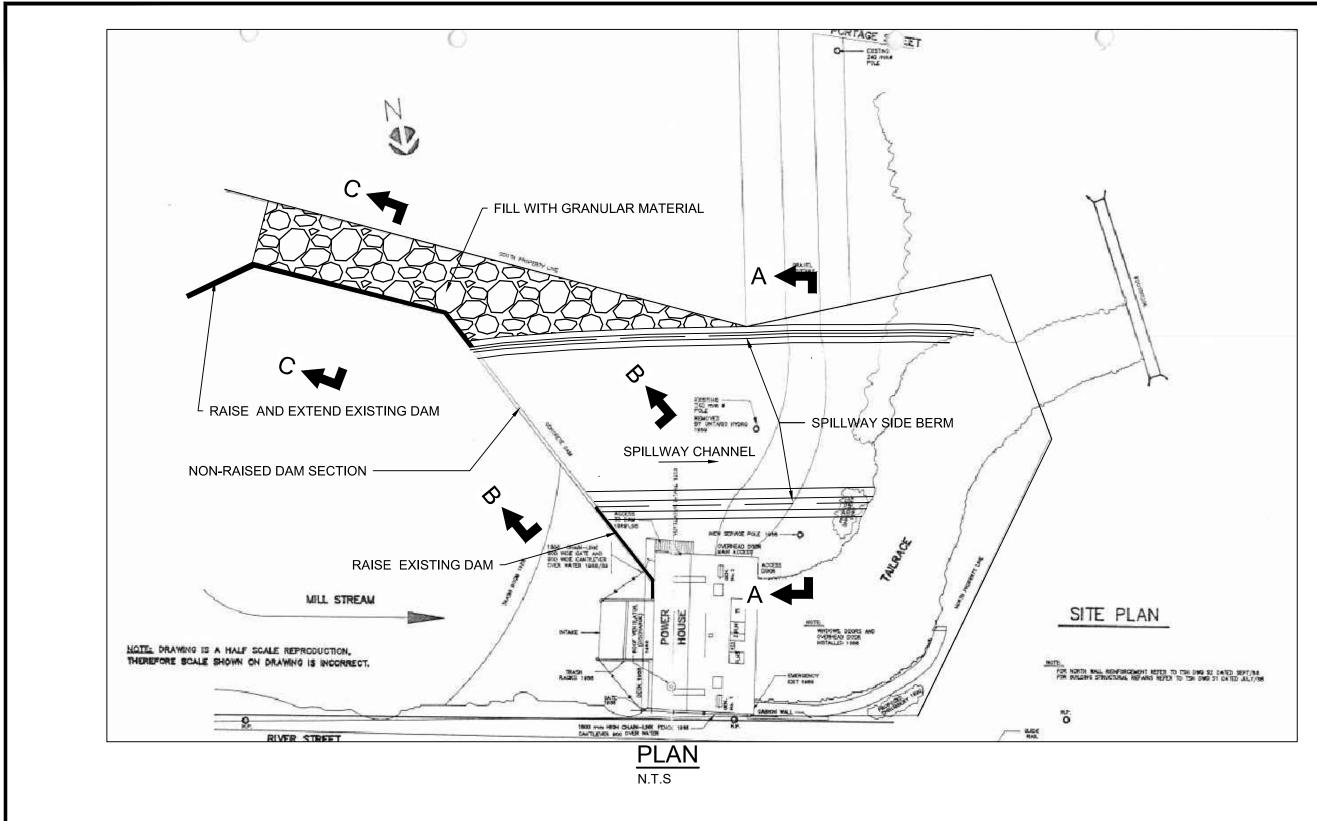
CLIENT:	DRAWN BY:	CHECKED BY:	DESIGNED BY:
TOWNSHIP OF	K. KORTEKAAS	E. GILES	G. LIANG
MUIOLOUA LALVEO			
MUSKOKA LAKES	APPROVED BY:	SCALE:	DATE:
PROJECT:	G. LIANG	AS NOTED	2019-08-07
BURGESS DAM 1			
DUNGESS DAIN I	DRAWING No.		REVISION No.
DAM SAFETY ASSESSMENT	19-1493-C-04	A

NON-OVERFLOW DAM SECTION
OPTION N2
UPGRADED DOWNSTREAM FILL
WITH SPILLWAY -PLAN

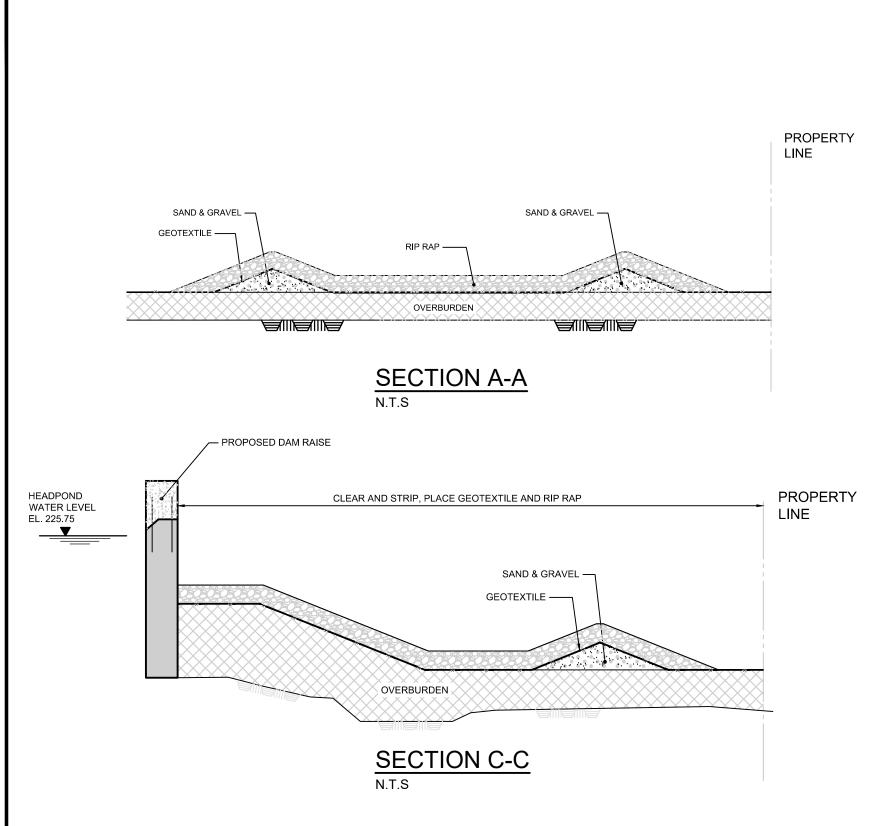
CLIENT:	DRAWN BY:	CHECKED BY:	DES	IGNED BY:
TOWNSHIP OF	K. KORTEKAAS	E. GILES	G.	LIANG
MUSKOKA LAKES	APPROVED BY:	SCALE:	DATI	E:
PROJECT:	G. LIANG	AS NOTED	20	19-08-07
BURGESS DAM 1	DRAWING No.			REVISION No.
DAM SAFETY ASSESSMENT	19-1493-C-05		A

HEADPOND
WATER LEVEL
EL. 225.75

RIP RAP

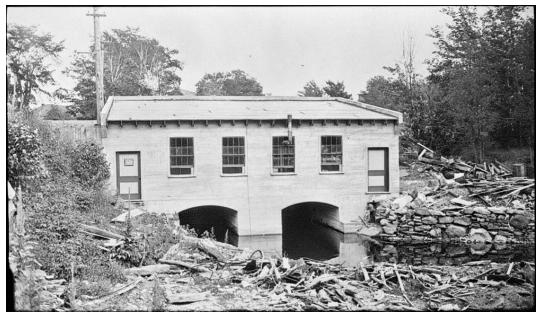
Image 1: Photograph of Burgess Dam from 1917

The outside of the structure appears to not have changed since its construction in 1917 (**Figures 1-6, Image 1**). However, the interior has been updated (**Figures 7-11**), probably to bring it up to modern safety and energy standards. However, one of the original Francis-type turbines built by William Hamilton is still located within the structure, although it is unknown if it us functioning or simply sitting in place (**Figure 12**).

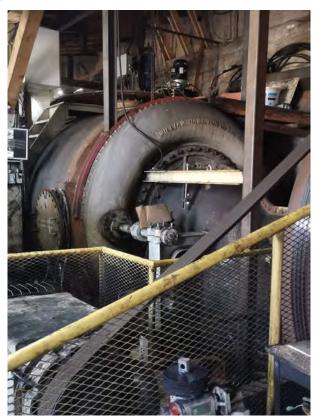
Figure 12: Original William Hamilton turbine

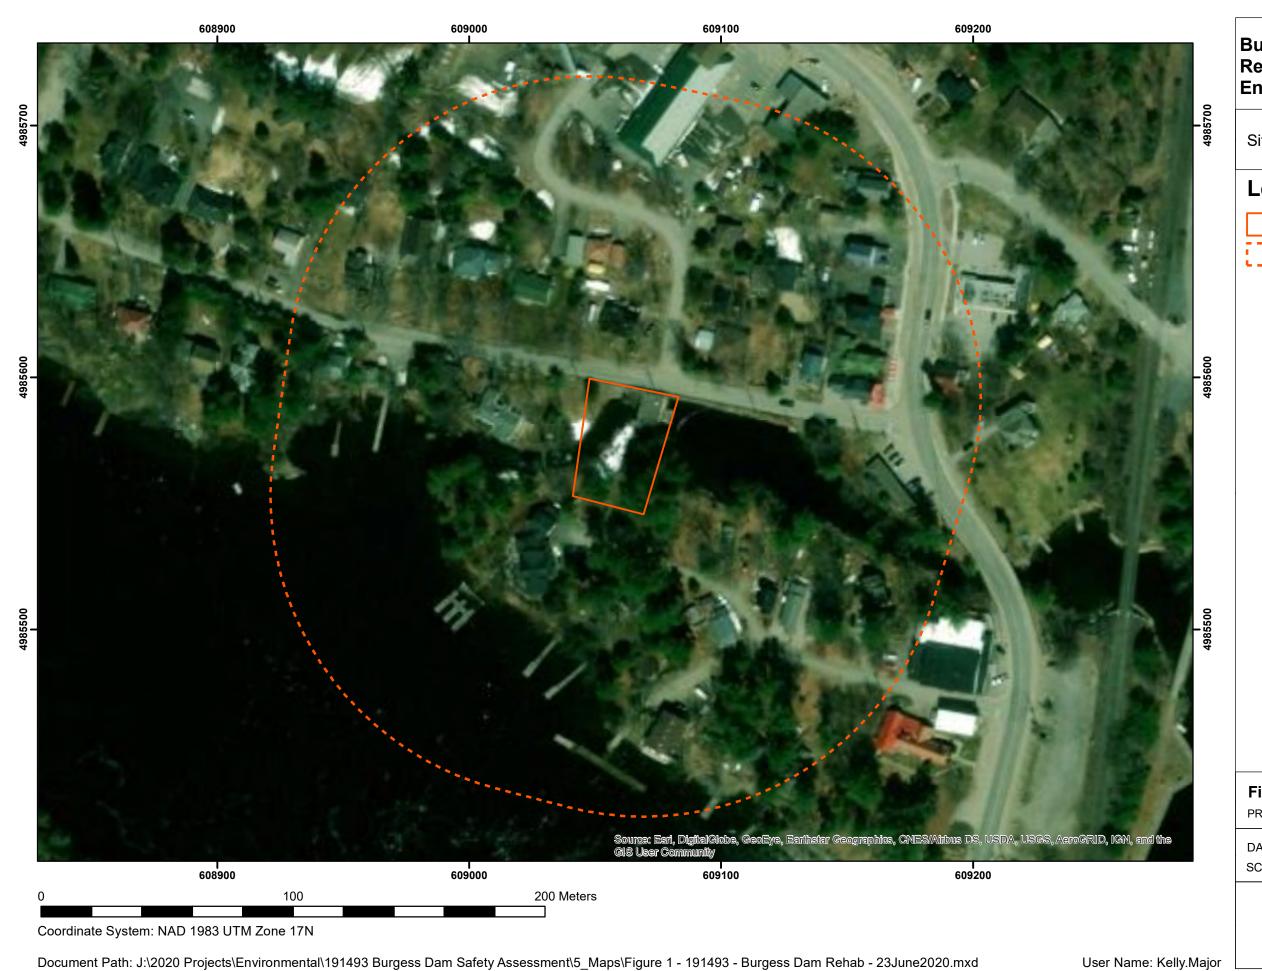
Figure 1

The existing structure (henceforth referred to as Burgess Dam) is an approximately 59 m long and 3 m high concrete dam (Figure 1). The powerhouse is approximately 9m x 14m including the turbine, generator and associated equipment. A retaining wall 16m in length connects the north wall of the powerhouse and supports River St. immediately North of the powerhouse. The Burgess Dam runs across the north channel of the outlet from Lake Muskoka to the Moon River in Bala, Ontario; UTM (NAD83) 17T 609163 4985226.

The Study Area (Figure 1) was investigated using general reconnaissance methods performed on foot. Aerial imagery of the Study Area was evaluated prior to field assessments to identify priority areas. Survey effort varied across the Study Area depending on the potential for an area to possess Natural Heritage features, as well as the topography and homogeneity of the site.

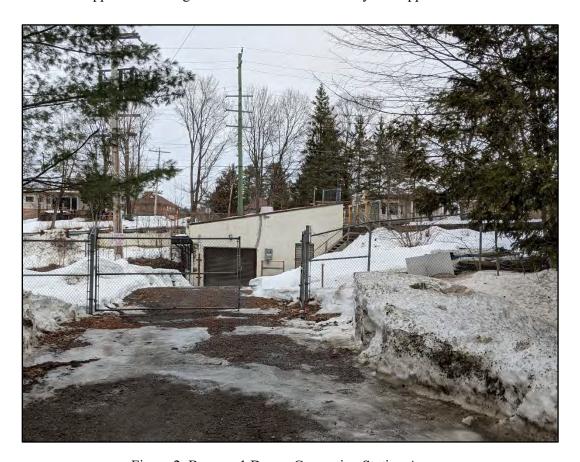
Access to the station is unobstructed and provides ample space for laydown and mobile crane access. The upstream channel surrounds neighbouring public properties and narrows substantially at a vehicle overpass. The headgate is fabricated in steel and appears to be in good condition and trashrack system appeared clean and maintained.

Figure 2: Burgess 1 Dam – Generating Station Access

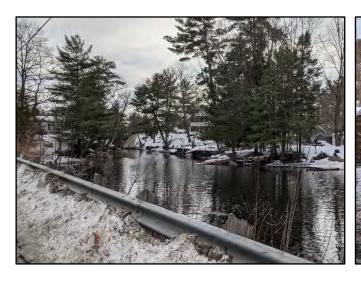
Figure 3: Upstream Channel and Intake Headgate System

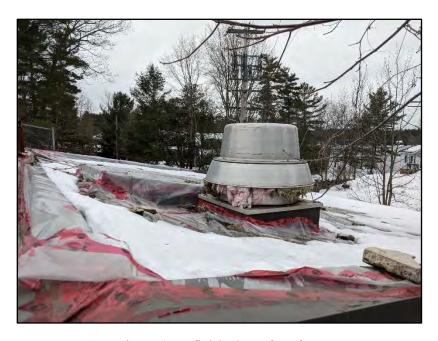
The roof is partially unfinished and covered in construction polypropylene sheets to maintain the moisture barrier. Snow loads and heavy rainfalls could have significant impact on the structure if not properly maintained and inspected on a regular basis.

Figure 4: Unfinished Roof Surface

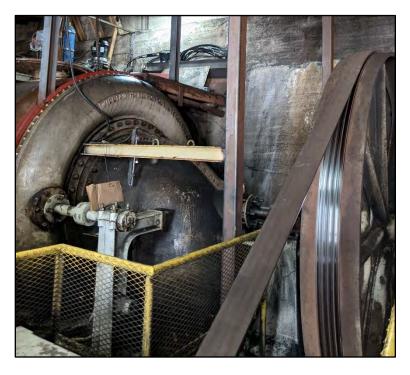
The station had originally installed two horizontal, Francis turbines inside a pressure case. Each turbine shaft was coupled to a high-speed generator by a large belt driven system on the end of the shaft.

Figure 5: Original Turbine Equipment (Right-Hand Side)

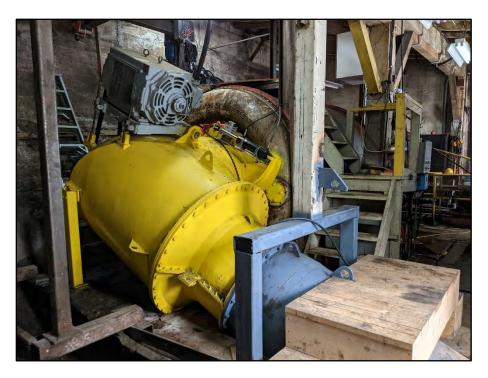
A recent modification to the machine on the left-hand side (looking upstream) was completed where a new turbine has been retrofitted to one side of the pressure case. Limited information is available, but the turbine appears to be an inclined propeller turbine operating with the original belt driven generator

Figure 6: Recent Machine Modification (Left-Hand Side)

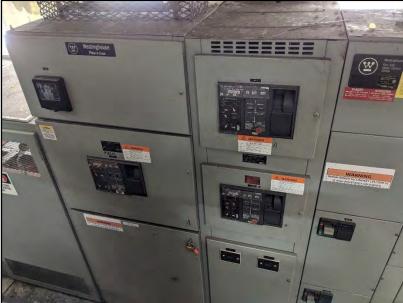
Figure 7: Generator Nameplate and Electrical Cabinet

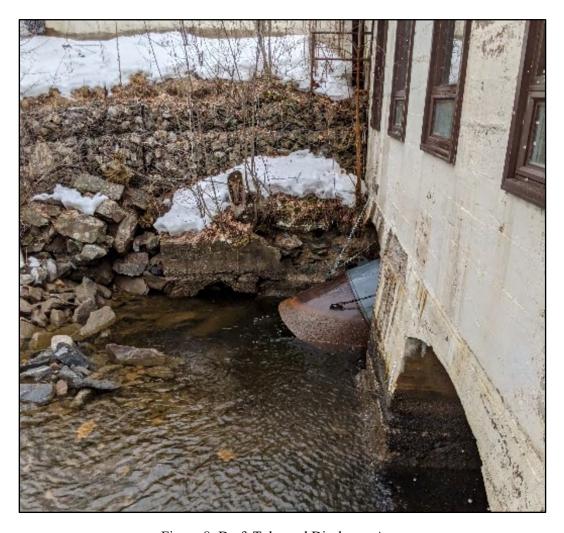
The draft tube and discharge area were not accessible, other than visually from near the bay door entrance to the station. The outlet of the draft tube of the modified turbine is obstructed by rocks from the nearby wall embankment. No visible observations were able to be made on the other machine's draft tube, which is assumed to be vertically conical in design.

Figure 8: Draft Tube and Discharge Area

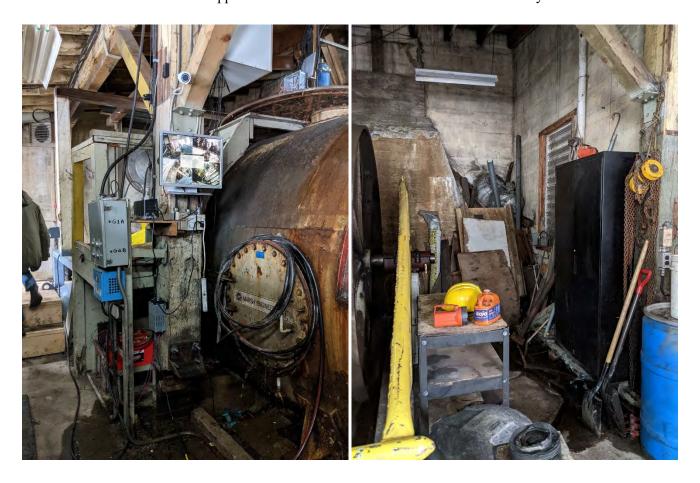
Improvements to the station's general cleanliness and organization would be beneficial. Dirt and grime are prevalent throughout the station and coat much of the stationary equipment. Sections of the concrete in the floor and walls have been cracked and broken or appear oil-stained and should be maintained consistently.

Figure 9: Station Cleanliness and Concrete Degradation/Oil Saturation

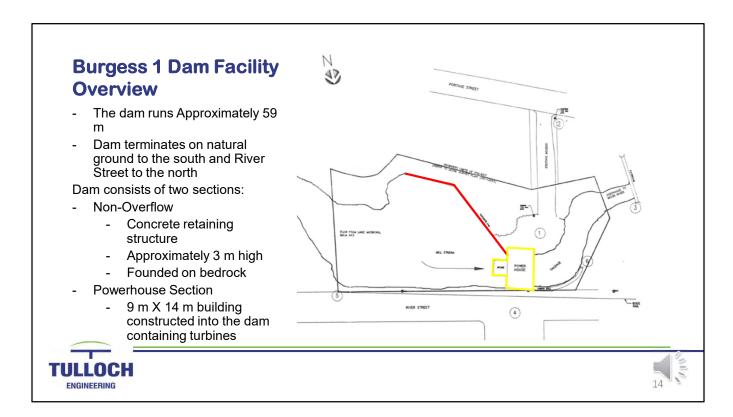
Pictured here is a general site plan of the Burgess dam. Please note to help orient yourself River Street is on the bottom and Portage is on the top. The dam runs approximately 59 meters from end to end. The south abutment of the dam terminates into natural ground whereas the north abutment of the dam terminates into the River Street embankment and also attaches to a concrete retaining wall that extends downstream of the facility along the south side of River Street.

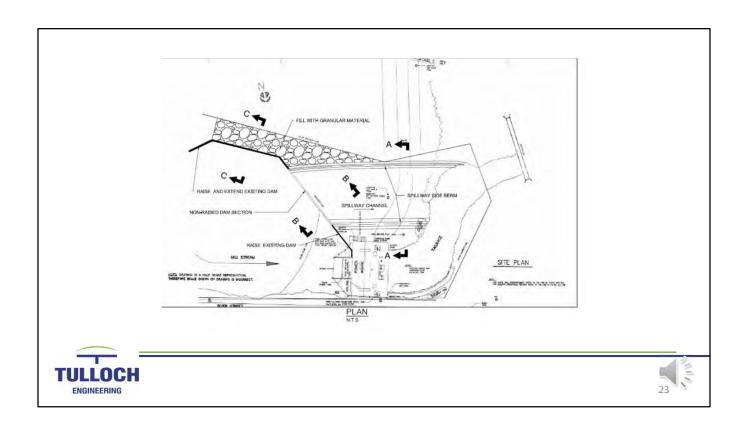
A conceptual mock up of this potential solution is presented in the slide above which was taken from the 2019 DSR. Here you can see what the addition of a partial dam raise in addition to the construction of a spillway and upgraded fill might look like over the existing site plan of the Burgess 1 Dam facility. Please note this is a conceptual mock up only and subject to change based on public consultation and further design analysis.
