# Little Burgess Dam Rehabilitation Existing Conditions and Environmental Impact Assessment

Township of Muskoka Lakes, Bala, ON.  
Project # 23-1236

16 May 2025

***Re: Existing Conditions and Environmental Impact Assessment (EC/EIA) for the Little Burgess Generating Station Rehabilitation, Township of Muskoka Lakes, Ontario; Tulloch Project # 230236***

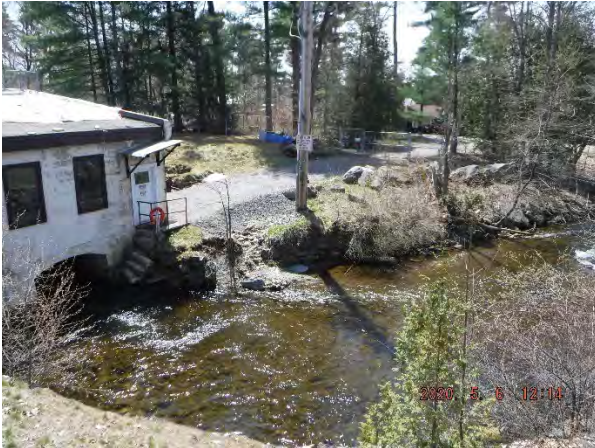
**Photo A** – Dam structure and south bank including access road and staging area as seen from the north bank.

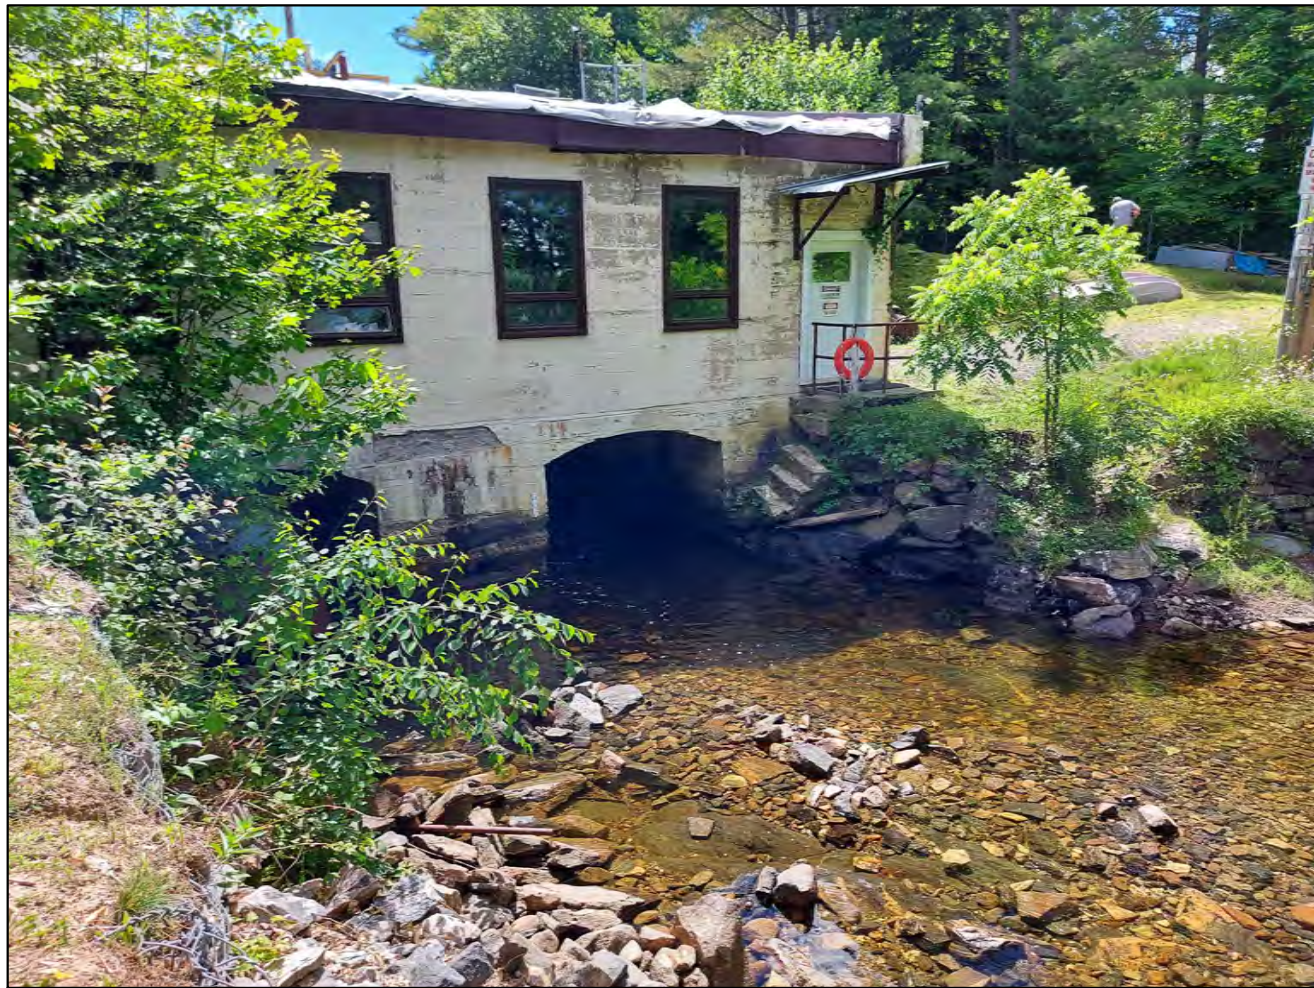
PHOTO 1  
DOWNSTREAM SIDE  
WEST ELEVATION LOOKING EAST

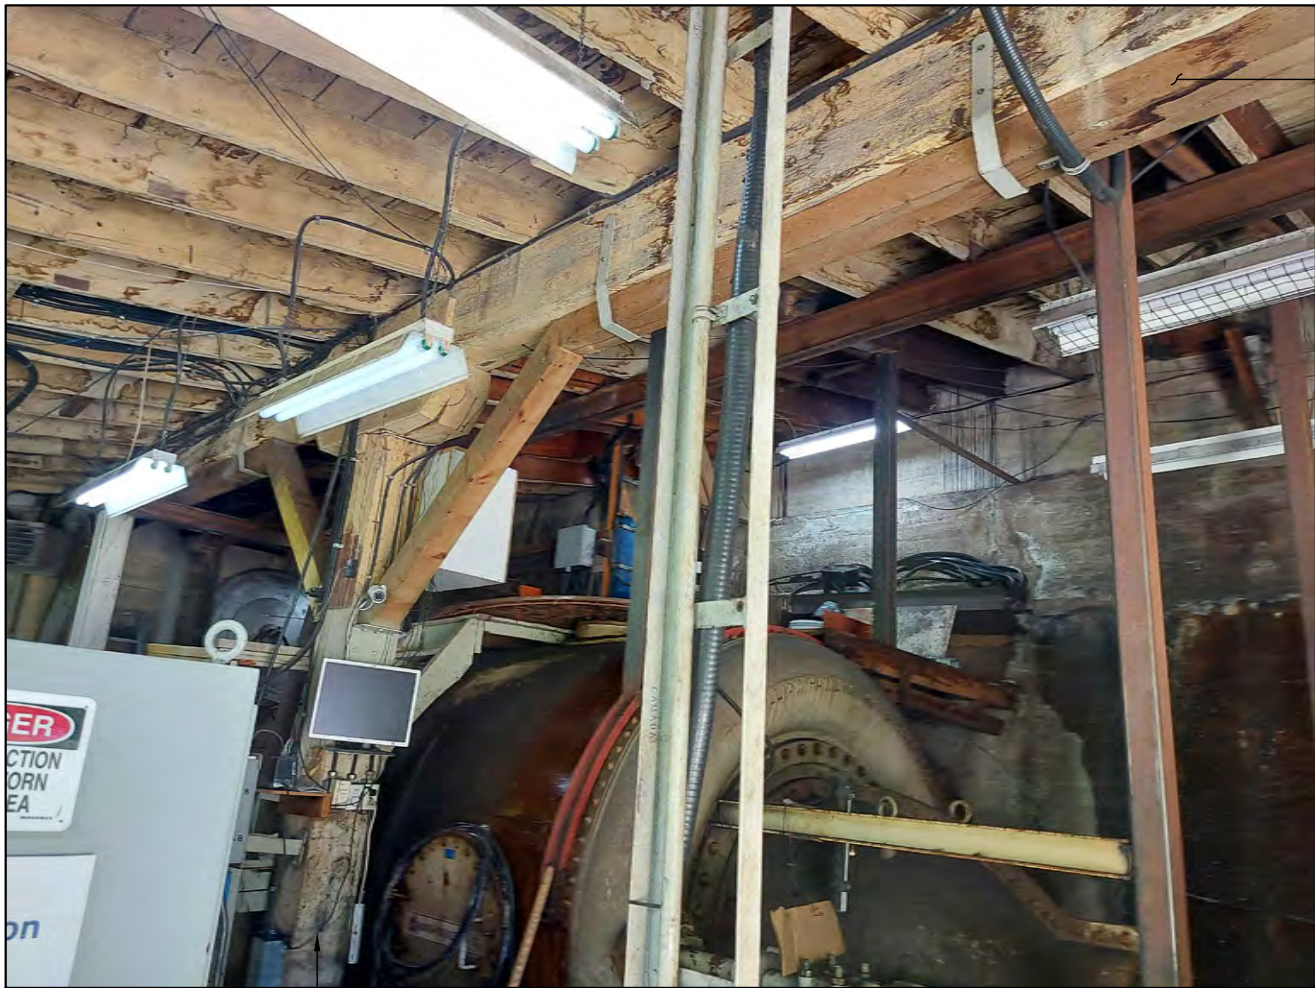
PHOTO 2  
EXISTING BEAM AND ROOF STRUCTURE

- REMOVAL NOTES**
1. REMOVE EXISTING WOOD FRAMED ROOF STRUCTURE AND REPLACE WITH NEW.
  2. REMOVE EXISTING WOOD TIMBER CENTRE BEAM AND EX. WOOD COLUMNS AND REPLACE WITH NEW STEEL.
  3. REMOVE ALL EXISTING STEEL COLUMNS ON NORTH WALL AND REPLACE WITH NEW.

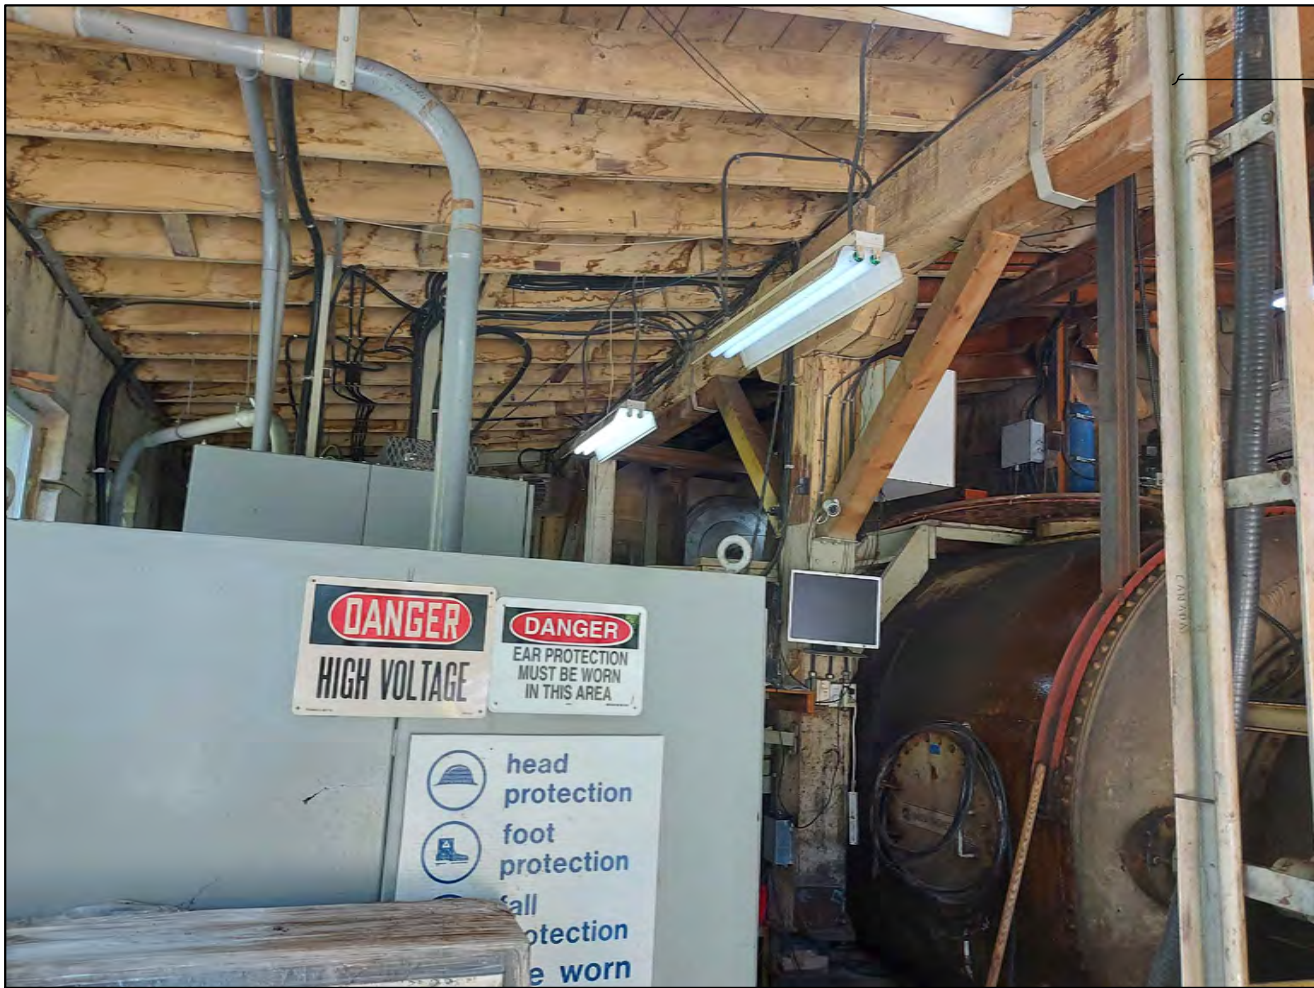
PHOTO 3  
EXISTING BEAM AND ROOF STRUCTURE

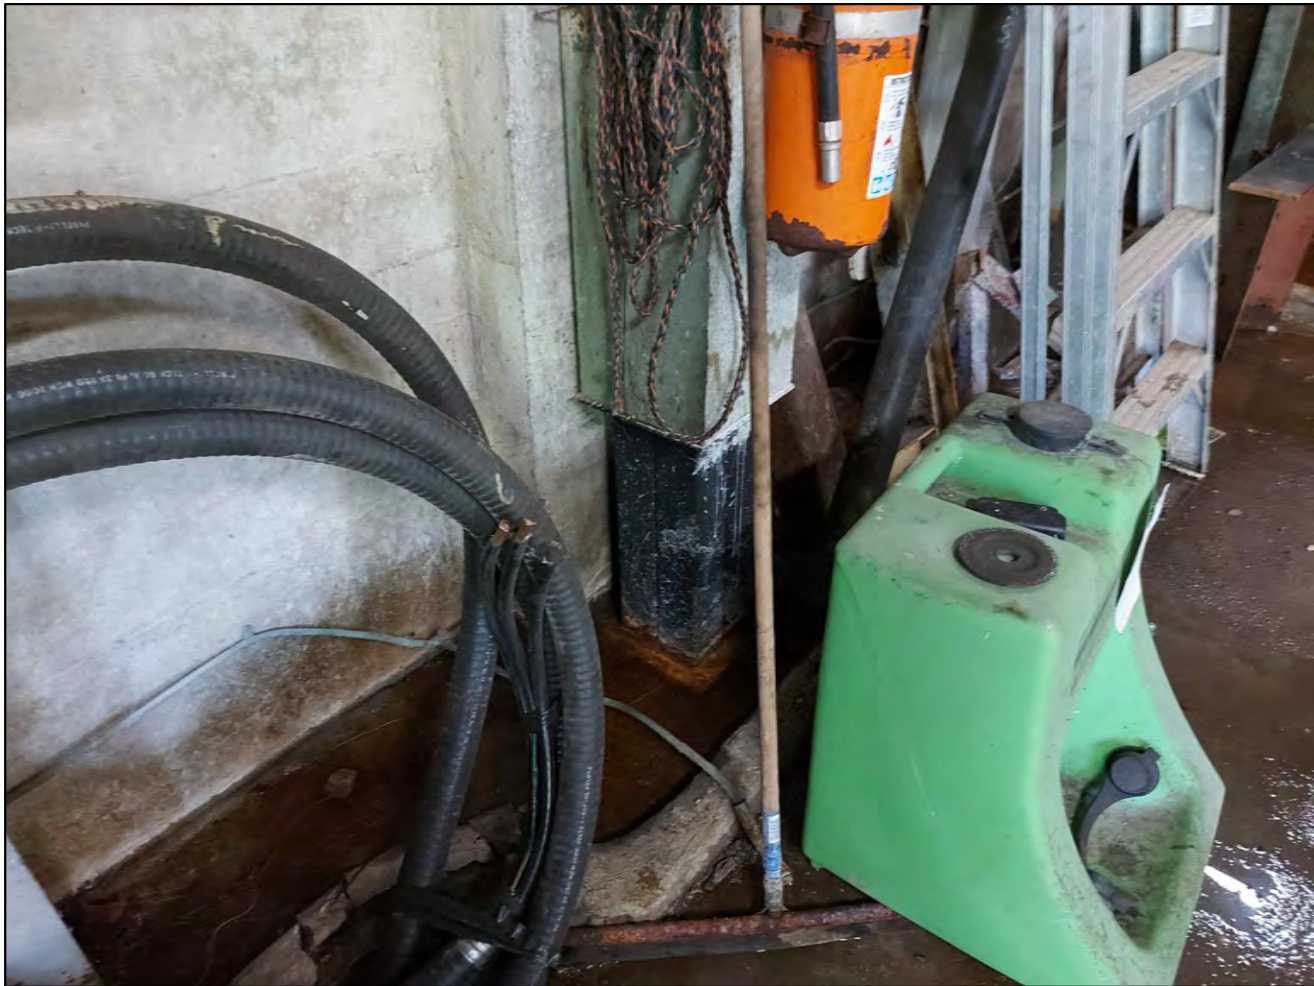
PHOTO 6  
EXISTING STEEL COLUMN BASE -- NORTH WALL

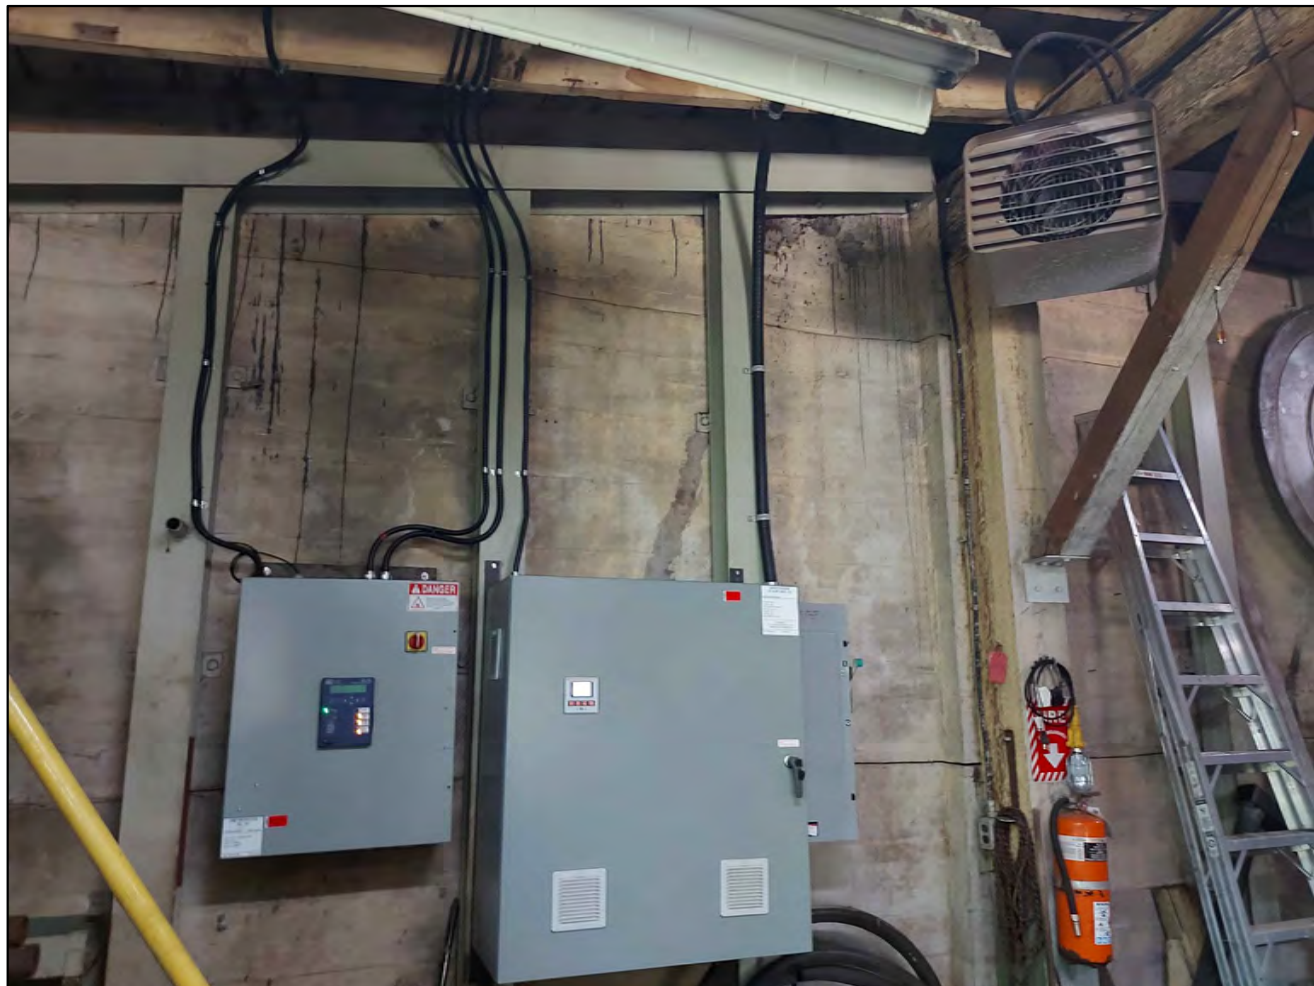
PHOTO 7  
EXISTING STEELWORK -- NORTH WALL

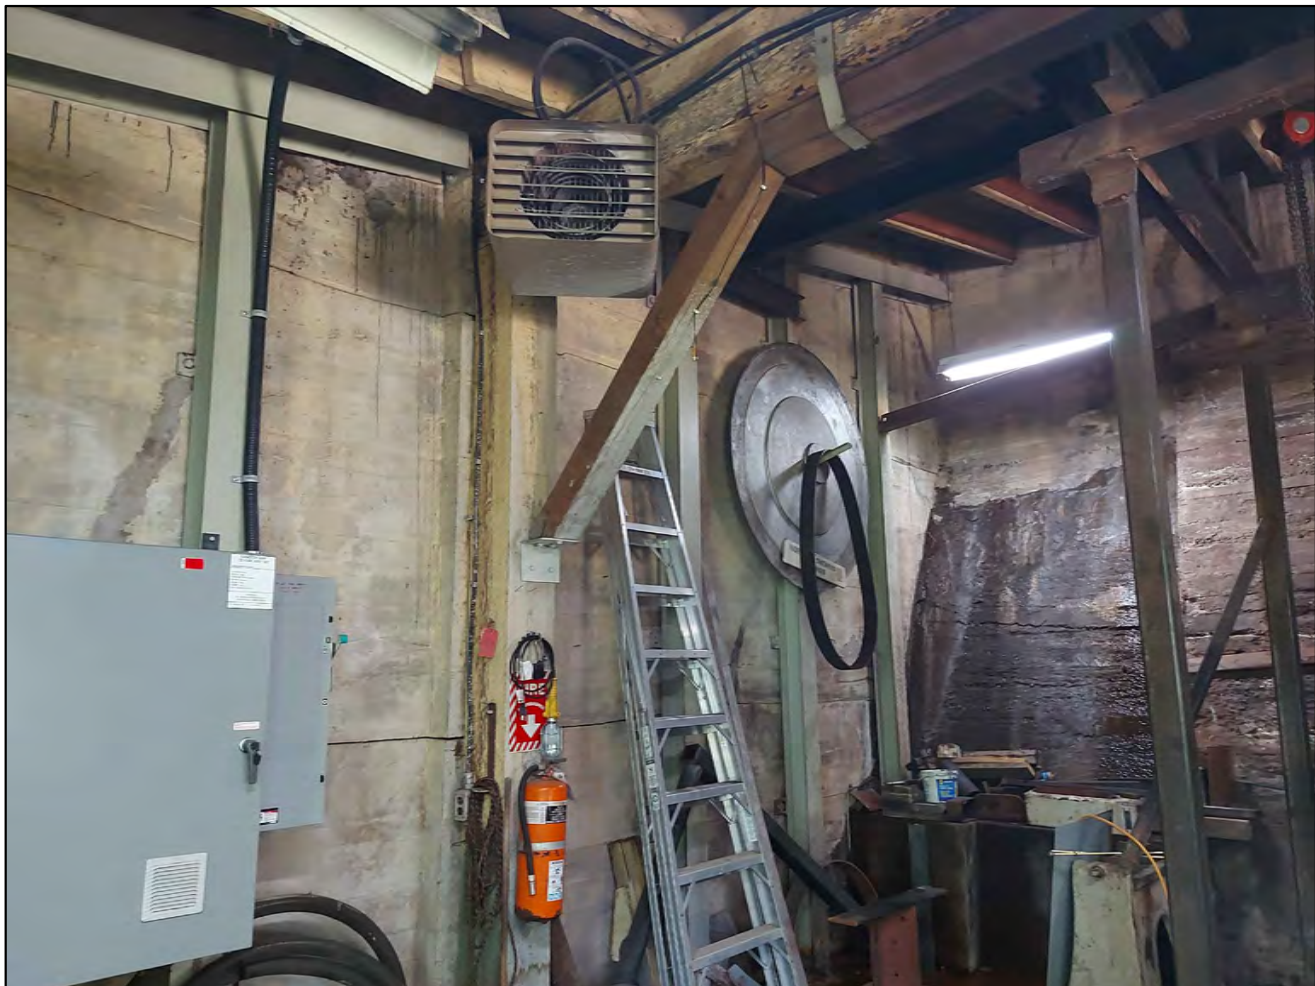
PHOTO 8  
EXISTING STEELWORK -- NORTH WALL
