MEMORANDUM

Date: Thursday, November 17, 2022

RE: Burgess Dam - North Slope Geotechnical Investigation and Slope Stability Analysis

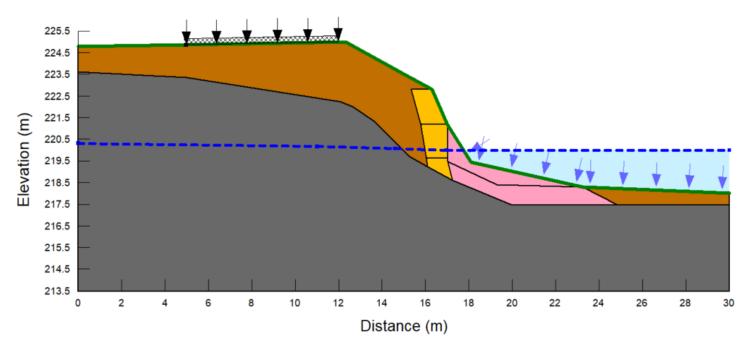
Burgess Dam – North Slope Investigation Township of Muskoka Lakes CONSULTANT YYYY-MM-DD 2022-03-08 North Slope - Failed Gabion Meshing PREPARED KC Geostudio LE Model Geometry and Parameters DESIGN KC REVIEW EG PROJECT No. Phase / Task Rev. 20-1051 G-4 APPROVED GL

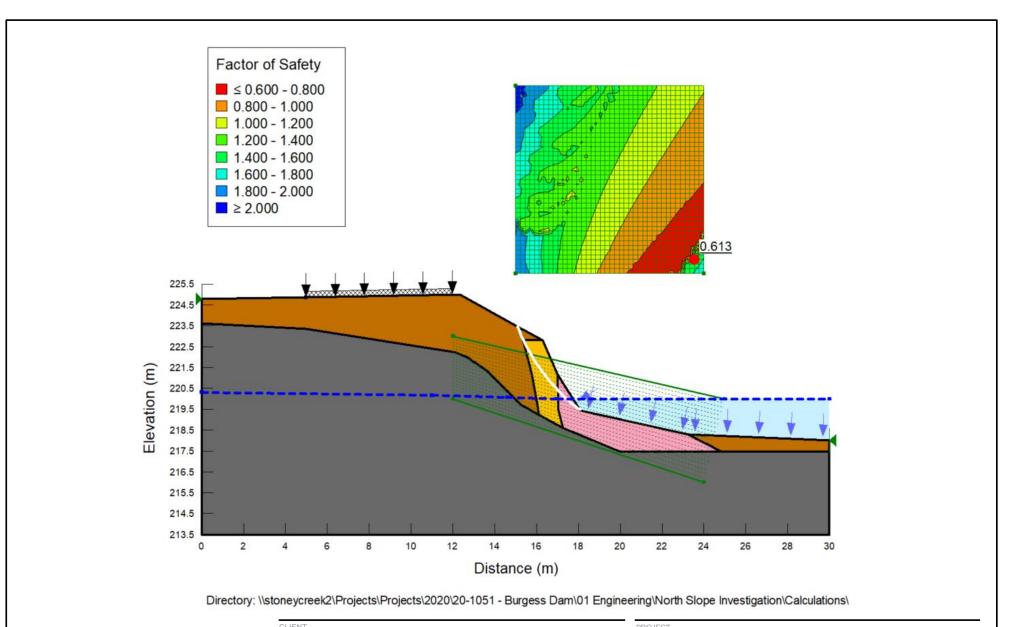
G-5

North Slope – Failed Gabion Meshing Geostudio LE Model Results

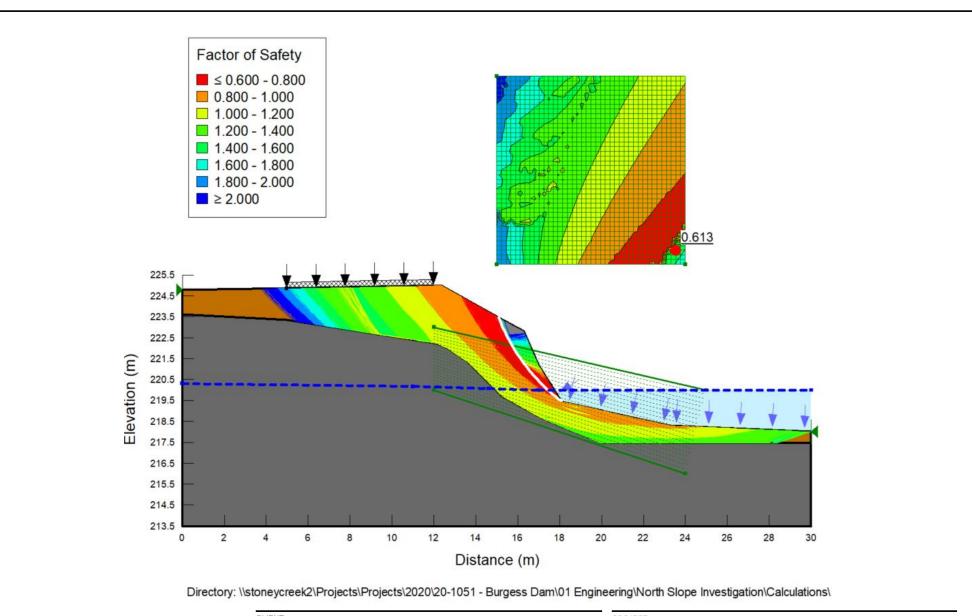
North Slope – Failed Gabion Meshing Geostudio LE Model Results
