Fire Station Location Study – Phase II: Development and Identification

Prepared for the Muskoka Lakes Fire Department

FINAL REPORT

April 2024

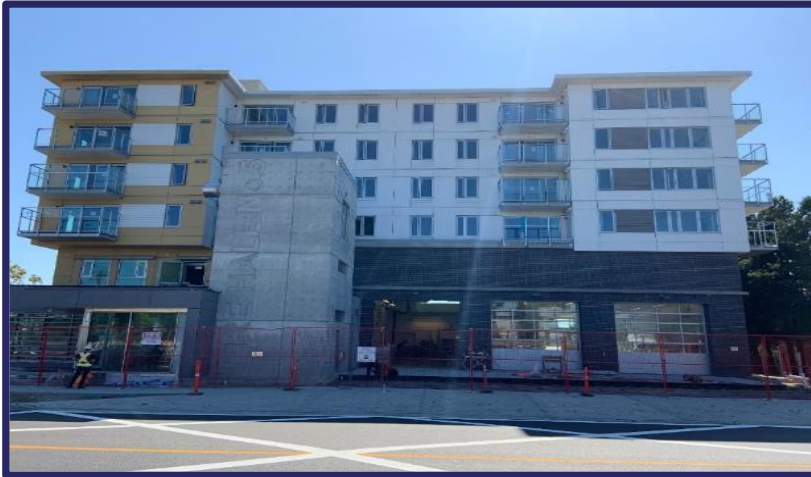
The following is the City of Vancouver Fire Station #5, which cohabitates a community housing project run by the YWCA. The two main floors comprise the fire station, with the upper four floors of the six-storey building providing 31 affordable housing units for single mothers and their children.

While the City of Vancouver funded the fire station, the YWCA housing portion of the building received funding from the municipal, provincial, and federal governments and the YWCA, which launched a capital fundraising campaign. Integrating the two services provides safety and security for single mothers and their children.

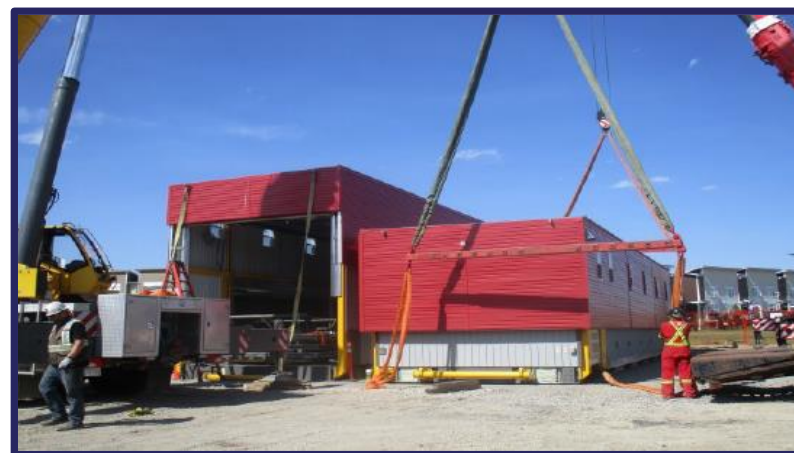
Extreme Fire Station Assembly (On-Site)

EXTREME fire stations are a new concept, a Canadian-built product out of Lethbridge, Alberta. It is a modular-based building, built to seismic and building code standards, using

high efficiency, energy code compliant HVAC systems and fire suppression systems; these are standard on EXTREME stations.

The positive aspects of EXTREME fire stations are that they are custom-built at a factory and transported to the site, where they are quickly ready for occupancy.

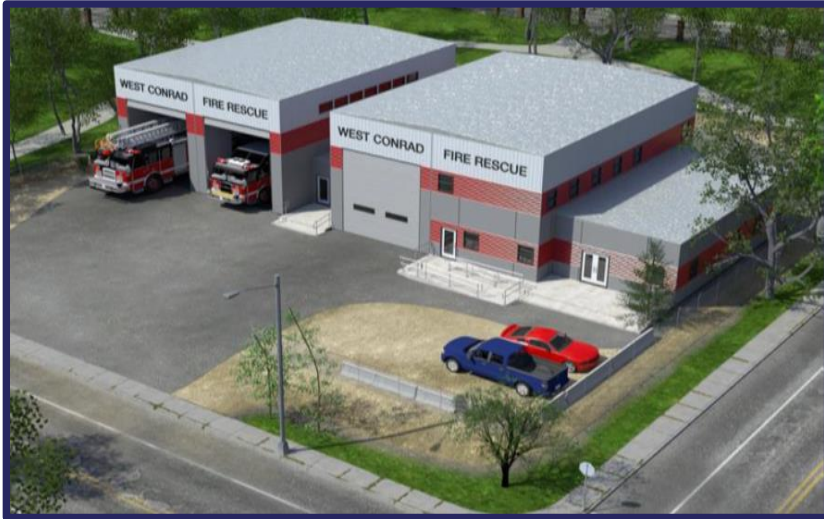
Extreme Fire Station (Multi-Bay Example)

A typical fire station has a life expectancy of approximately 30 to 50 years before the cost/benefit ratio starts to work against the municipality in terms of maintenance, essential function, and design. The EXTREME fire stations can meet and exceed that life cycle because they are made from steel and aluminum and can add modules if the station needs to expand its footprint.

The West Conrad station is an example of the diversity of EXTREME fire station designs and how they are constructed and expanded to meet the customer's needs.

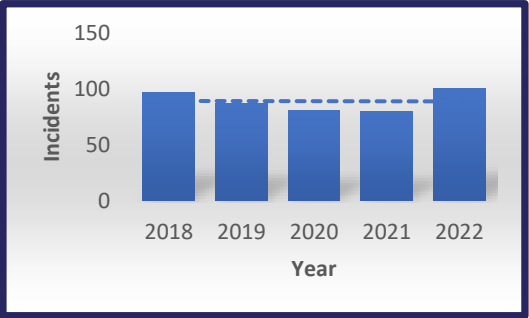
Year of Construction	2009 (14 years)	
Building Size	5,326 ft ²	
Apparatus Assigned	Pumper / Rescue / ATV	
Firefighters Rostered	15	
Incident Volume NOTE: Call volumes are reflective of Torrance and Walkers Point combined incidents.	2018: 97 2019: 87 2020: 81 2021: 80 2022: 100

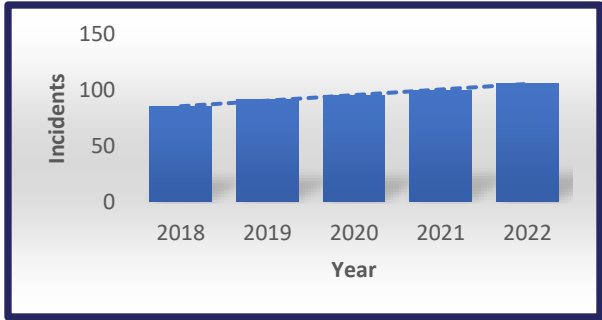
Year of Construction	1940 (83 years)	
Building Size	3,748 ft ²	
Apparatus Assigned	Pumper / Tanker / Rescue / ATV	
Firefighters Rostered	15	
Incident Volume	2018: 85 2019: 92 2020: 95 2021: 100 2022: 106

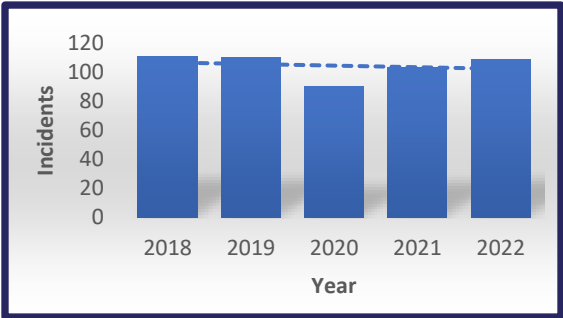
Year of Construction	2009 (14 years)		
Building Size	6,367 ft ²		
Apparatus Assigned	Pumper / Tanker / Rescue / Marine (Inflatable)		
Firefighters Rostered	19		
Incident Volume	2018: 111 2019: 110 2020: 90 2021: 103 2022: 109

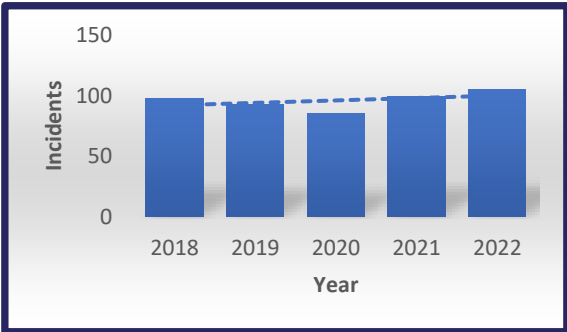
Year of Construction	1980 (43 years)													
Building Size	2,050 ft ²													
Apparatus Assigned	Pumper / Tanker / Rescue													
Firefighters Rostered	17													
Incident Volume NOTE: Call volumes are reflective of Windermere and Raymond incidents combined.	2018: 98 2019: 93 2020: 85 2021: 99 2022: 105

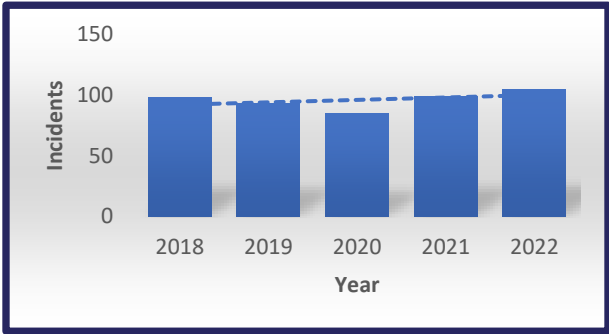
Year of Construction:	1995 (28 years)														
Building Size:	2,930 ft ²														
Apparatus Assigned:	Pumper / Tanker / ATV														
Firefighters Rostered:	17														
Incident Volume: NOTE: Call volumes are reflective of Windermere and Raymond incidents combined.	2018: 98 2019: 93 2020: 85 2021: 99 2022: 105
